Tower Failure

INCIDENT

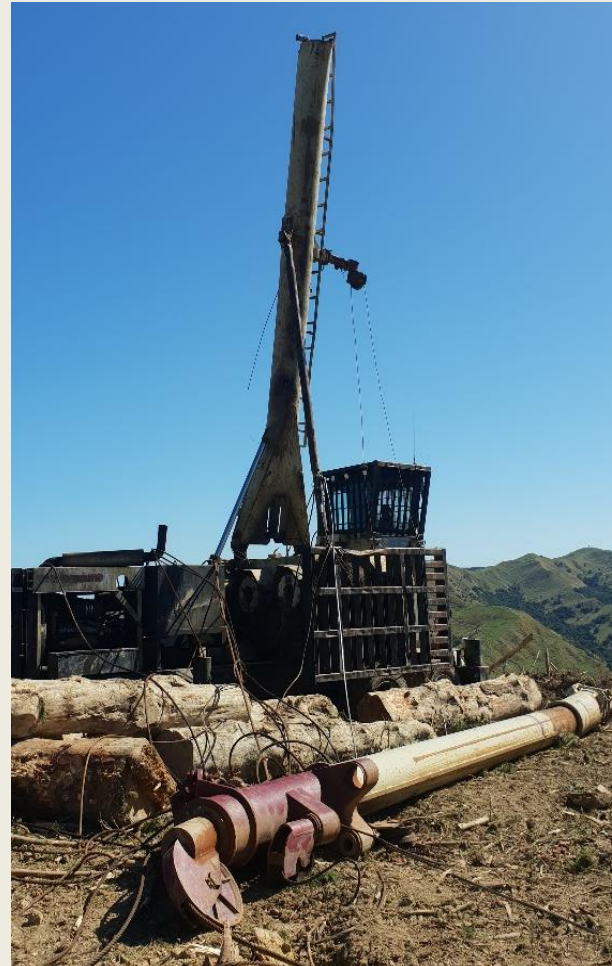
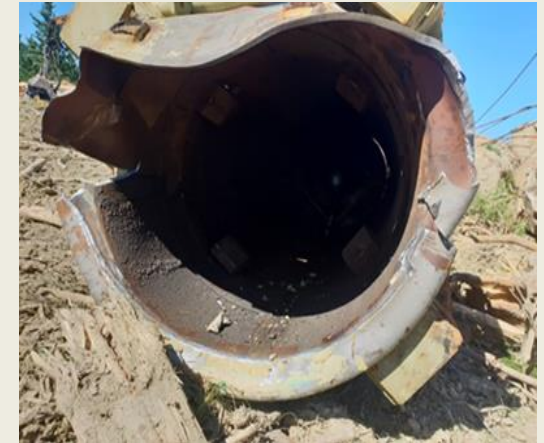
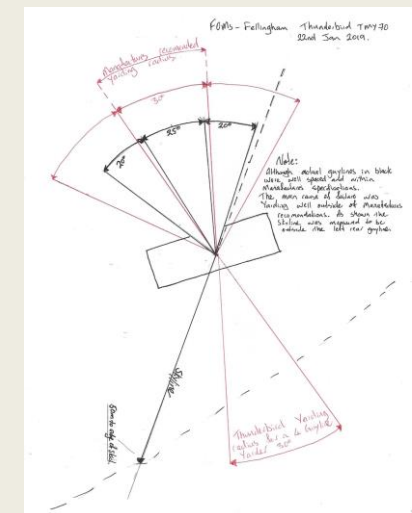
A Thunderbird TMY70 running an ACME carriage and set at 70ft was being operated in a steep hauler setting. The crew had carried out a number of line shifts throughout the day. On the last planned line of the setting a tower failure occurred and destroyed the bottom section of the pole at mid height.

Crew has operated machine outside of manufacturers specifications - this has placed all the weight on the outside guyline. When logs being hauled have hit stumps, the shock wave has gone through one guyline rather than all four, resulting in the shock wave hitting the tower unevenly, causing it to crumple sideways and snap off.

- 1) UNDER NO CIRCUMSTANCES should machinery be operated outside of manufacturers specifications and guidelines.
- 2) Position haulers to ensure they are operating within lead and at acceptable angles.
- 3) Before operation at the beginning of the day and after any line shift all guys/stumps and deadman should be checked and documented as ok including guy angles.
