PIPE REHABILITATION

Restoring a corroded sewer

Robert Kelly & James Smolik describe the use of CCCC techniques to renew a concrete sewer that had suffered extensive hydrogen sulphide corrosion

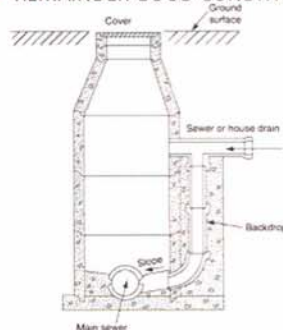
- **HYDROGEN SULFIDE CORROSION WAS SEEN AT ALL MAJOR TRUNK LINES (6) DUE TO DROP MANHOLES**

- 50' +/- MANHOLE
- REMAINDER GOOD CONDITION

Typical manhole (left) with typical effects of corrosion (right)

At the majority of locations, corrosion from sulphuric acid was confined to within 7.5-15m either side of the manhole, with the remainder of the interceptor in good condition. This concentration resulted from trunk lines with drop connections.

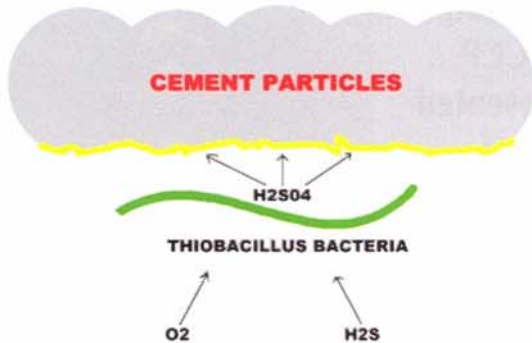
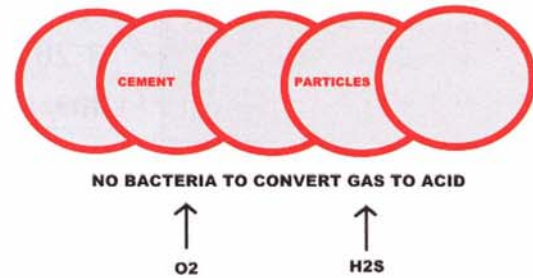
Vertical-drop manholes of trunk lines cause severe turbulence in the interceptor, releasing large amounts of hydrogen sulphide gas, produced from anaerobic bacteria in the sewage. Over time, the effects of carbon dioxide and hydrogen sulphide lower the concrete pipe's surface pH to below seven, thereby providing an ideal environment for *Thiobacillus*

Left: corrosion process
Right: barrier protection

In the presence of oxygen, hydrogen sulphide gas reacts with the Thiobacillus bacteria in this region of the pipe, converting it into sulphuric acid through an aerobic-biological process. Sulphuric acid then attacks the concrete pipe, which can lead to structural failure.

Anti-microbial agents hinder the Thiobacillus bacterial growth on the interior surface of the pipe. This prevents the aerobic-biological process of hydrogen sulphide gas converting to sulphuric acid. The high compressive strength of the cementitious coating also improves the ring compression of the pipe.

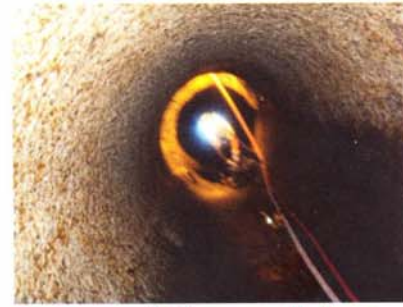
Operator controls Spincaster application rate

The CCCP coating was applied as a 12mm-thick layer on the surface of the prepared pipe by a

spin-caster; this was pulled through at a uniform rate using compressed air to apply the pumped, cementitious coating around the circumference of the pipe.

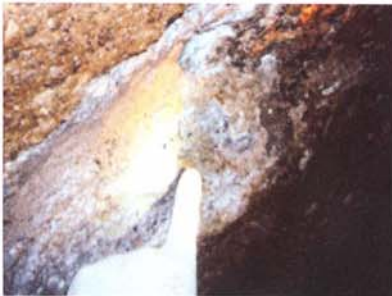
Organic matter and deteriorated pipe

Once a bypass was established, the sewer pipe was prepared for rehabilitation. Man entry was undertaken with compressed air and high-pressure water to clean the pipe of any organic matter and/or deteriorated pipe fragments. Compressed air was also used to dry →
