The Journal for Surface Water Quality Professionals Stormwater

October • 2010

Clay County, FL

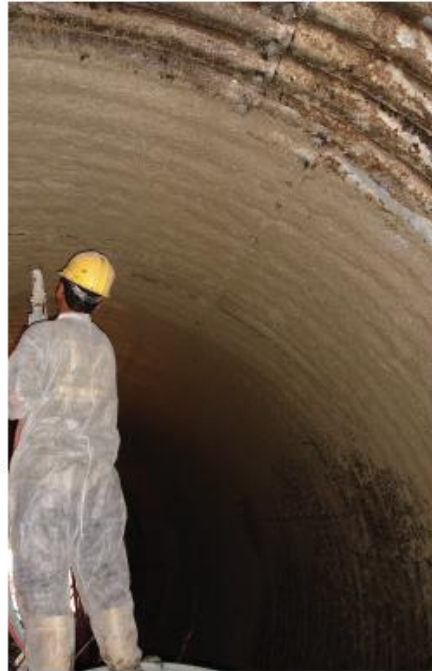
Spraying on the Permaform. The corrosion is visible to the right.

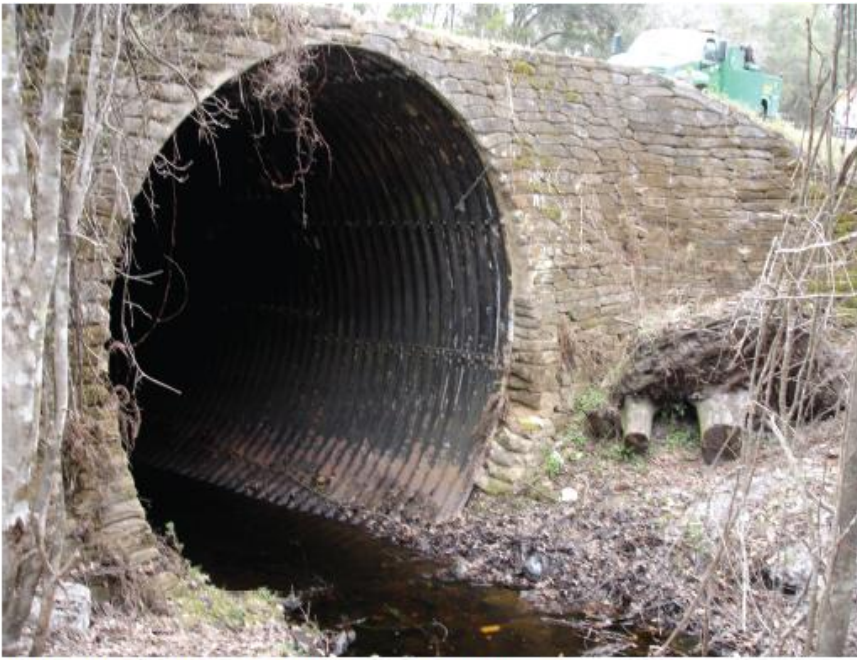
The Clay County culvert pipe before the project began

Workers pressure-washed the wall of the pipe, which had been treated with bitumen to prevent rust. Because of its age, though, it was corroded where the surface of the water met the air. They built an approach slab and wing walls at one end of the pipe and a departure slab with wing walls at the other.

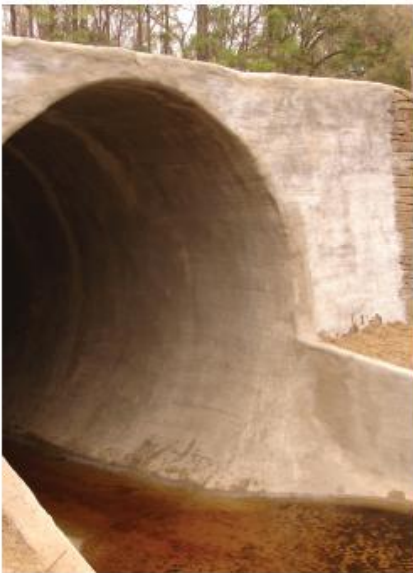
The pipe after project completion

One of the advantages of the material is that it cost about a quarter less than slip-lining, he says. Another is that it can be custom engineered. Because there was so little cover between the pipe and the road, the engineer on the project specified a maximum of 2 inches and a minimum of 1 inch of cover to be sprayed evenly inside pipe. Fortunately, the pipe was bolted together with bolts that extended 1 inch from the highest part of the corrugation. "We used that as a gauge," he says. "The bolts were consistent throughout the pipe."
