Georgia Water Authority Repairs Corrugated Metal Culvert

by Angus W. Stocking, L.S.

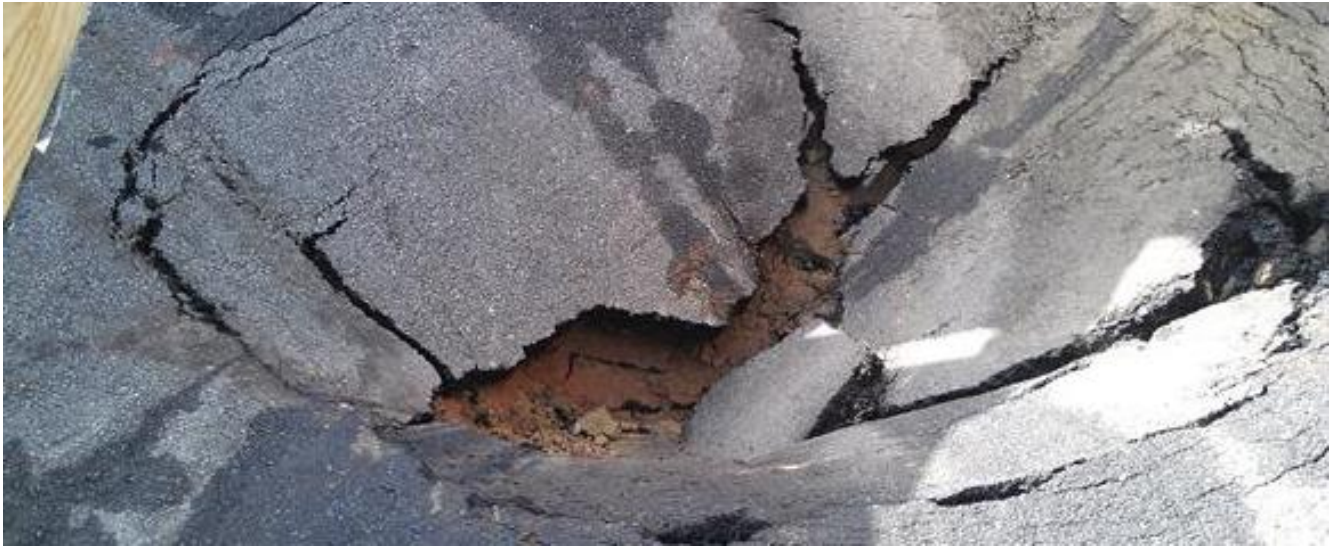
Parking lot sinkhole above collapsing CMP in Clayton County, GA

In one case, a 66-in., 20-ft deep, 220-ft long corrugated metal pipe (CMP) culvert was failing so dramatically that parking lots and commercial buildings overhead were subsiding noticeably and had to be monitored throughout subsequent rehabilitation.

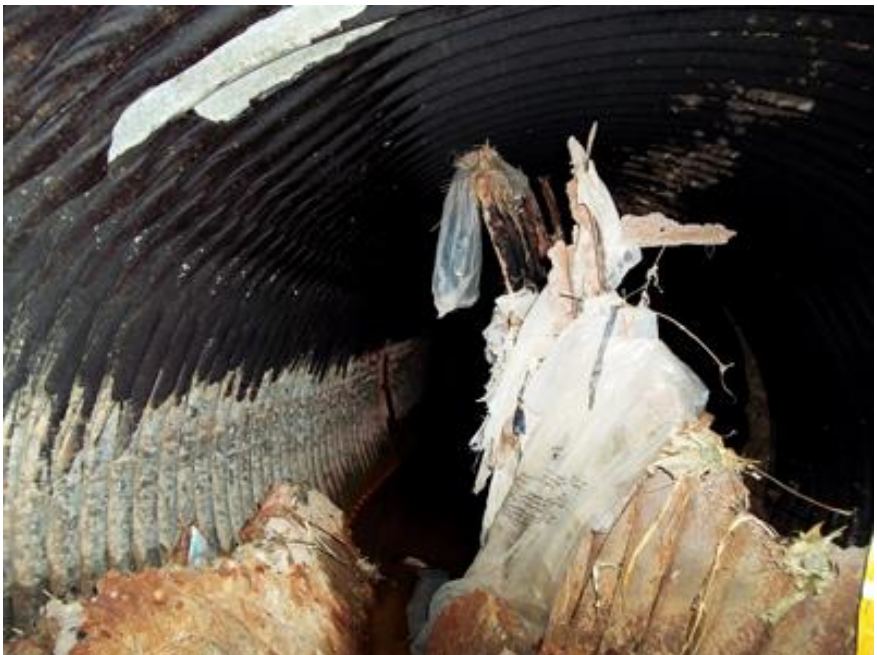
Inspection revealed inverts that were completely corroded, sidewalls that were curling up into the pipe interior and some collapsed pipe. After this discovery, the failure accelerated.

The 66-inch culvert collapsed even further between quote and award. There were completely corroded inverts and sidewalls curling up into the interior.

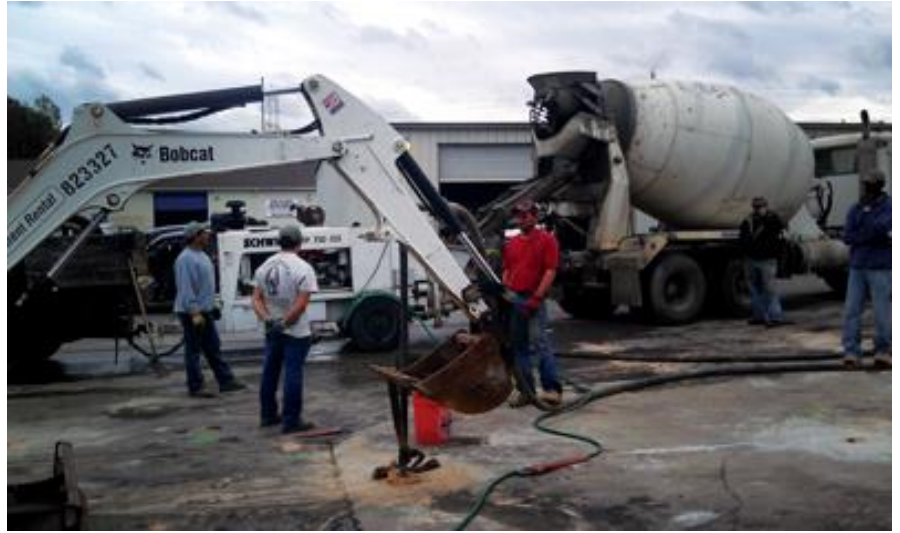
The third and final phase involved addressing the cause of the dramatic failure: the extremely unstable soil surrounding the pipe. To prevent similar problems for the rehabilitated culvert, CCWA called for stabilization of the surrounding soil with cementitious grout, which was injected until refusal.

To prevent soil instability, the team stabilized the surrounding soil with cementitious grout.
