CHC SAFETY & QUALITY
summit
DALLAS 2019

LOOKING AT THE RIGHT PLACES FOR HELIDECK SAFETY

Fernando Moraes and Morne Wiid

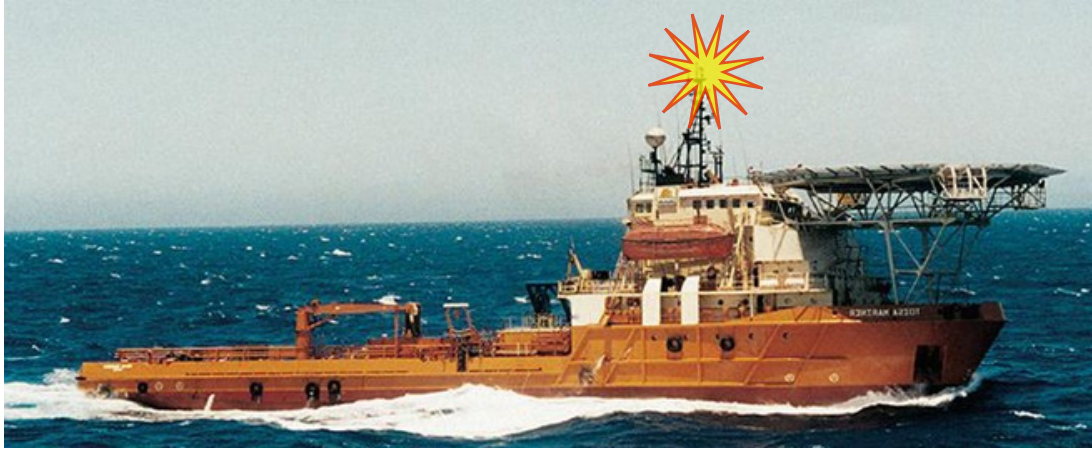
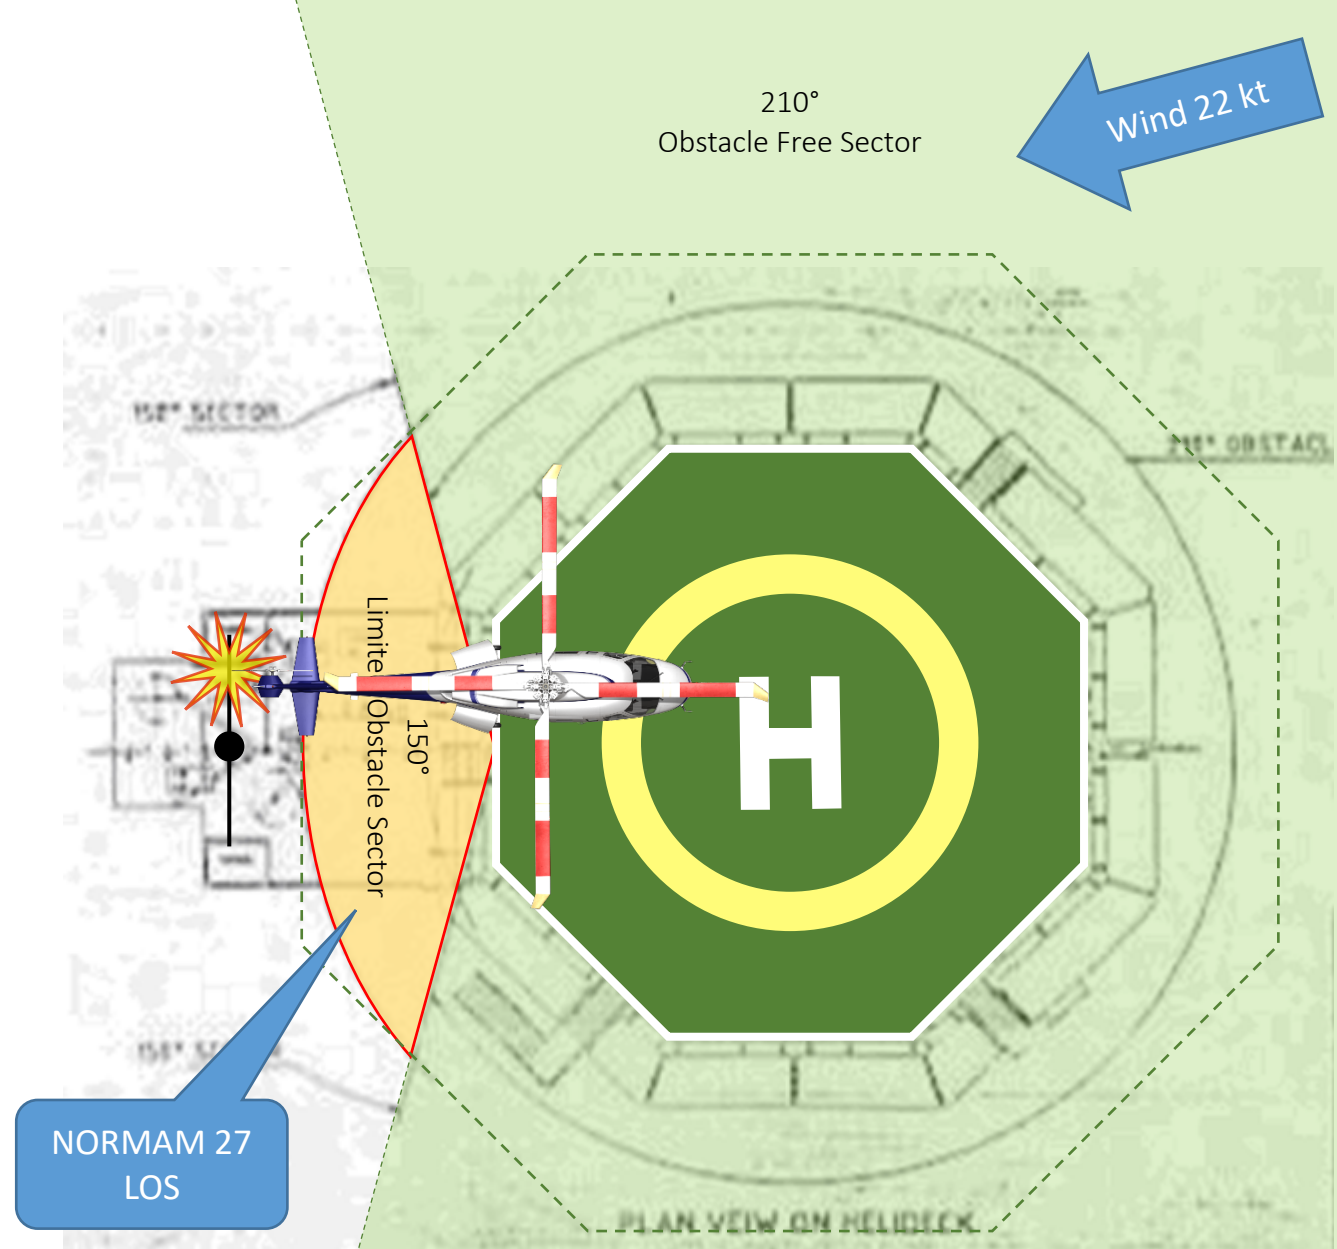
July 5, 2003: PT-YVM

- Vessel: Toisa Mariner
- NAA certified helideck, D-size 17,5m
- T/R impact on the yard of a mast outside the LOS, 8m high
- 5 fatal victims, no survivors

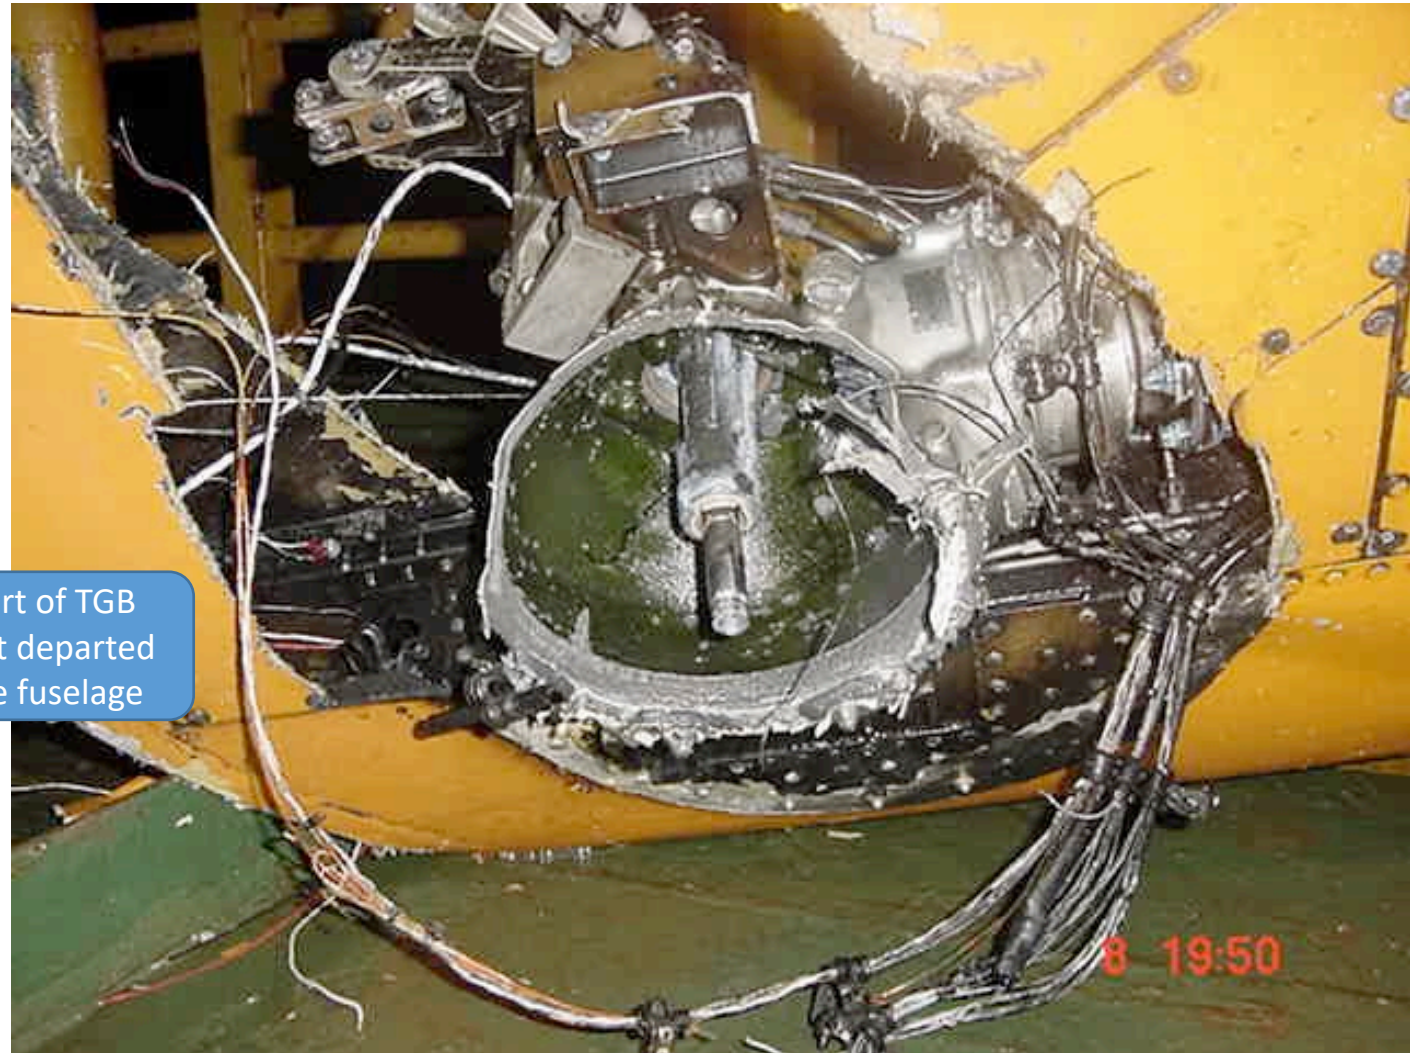
Part of TGB
that departed
the fuselage

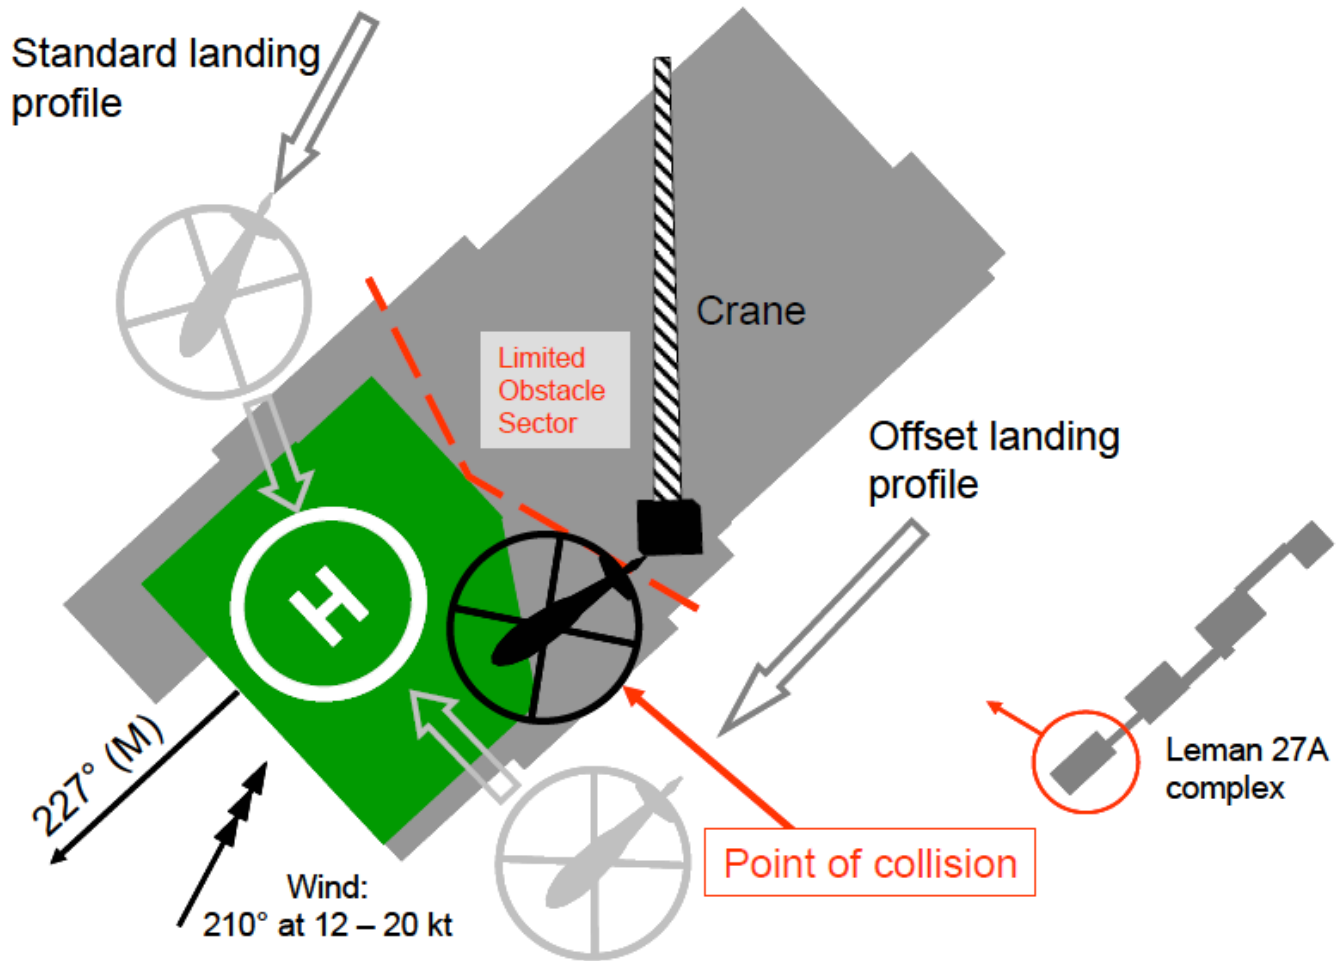
March 9, 2008: G-BKXD

“While maneuvering to land on an offshore helideck, the helicopter’s Fenestron tail fairing struck the guardrails of a deck mounted crane. Choice of approach profile, limited helicopter performance, approach technique and possible fatigue were considered to be factors in the accident”

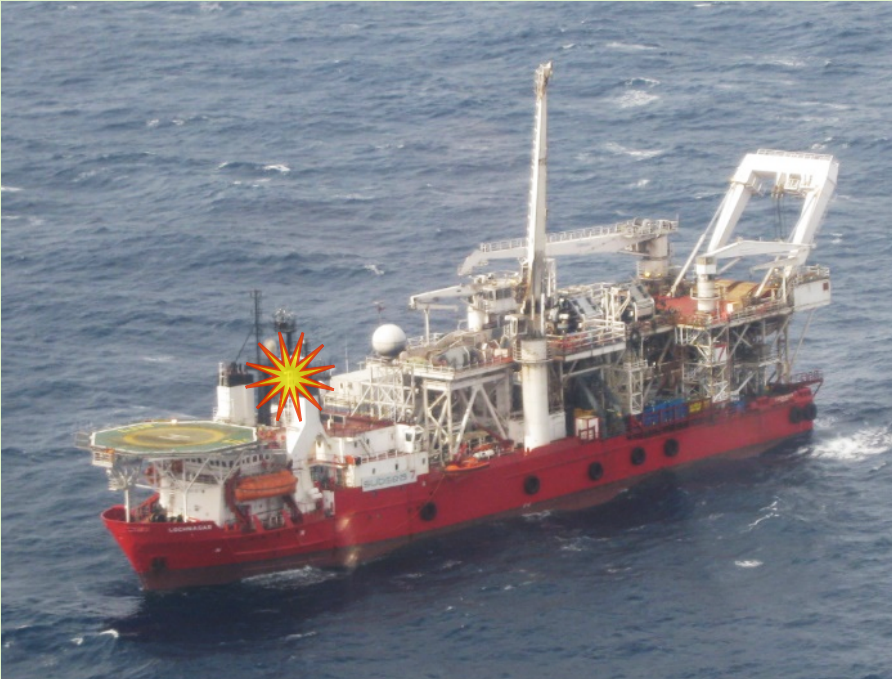
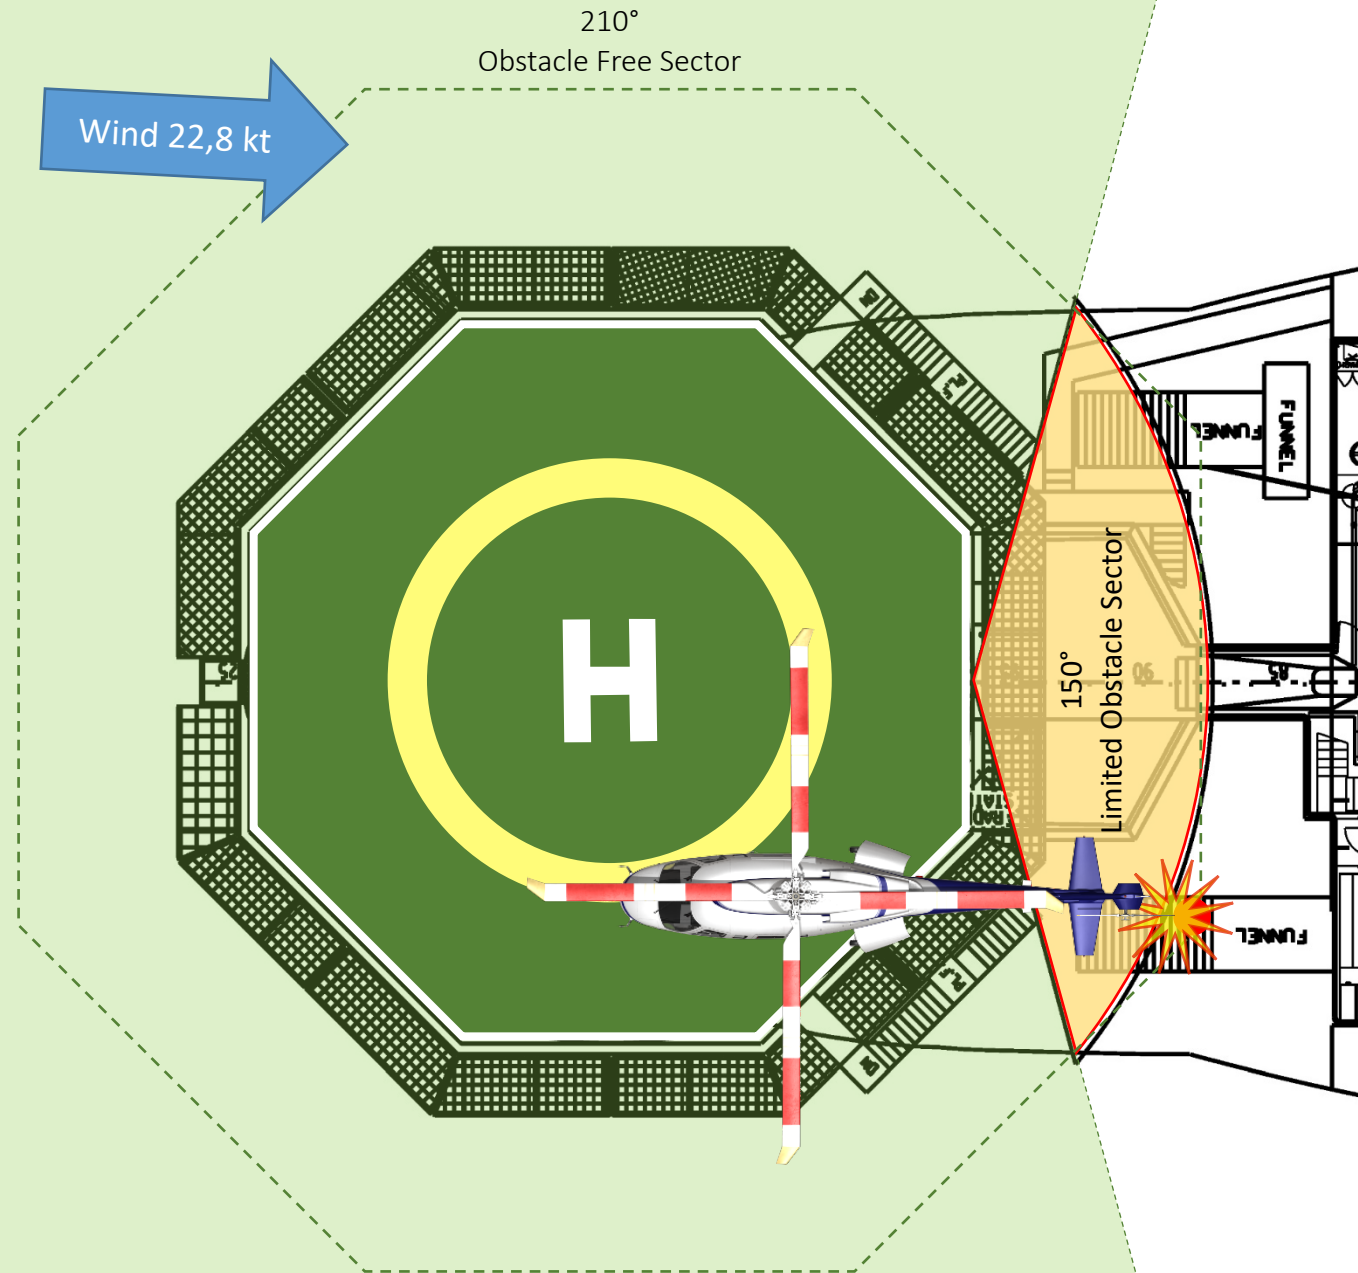
July 2, 2012: PR-CHO

- Vessel: Lochnagar
- NAA certified helideck, D-size 17,5m
- T/R impact on the top of the safety railing of a ladder attached to a smokestack, outside the LOS
- No victims

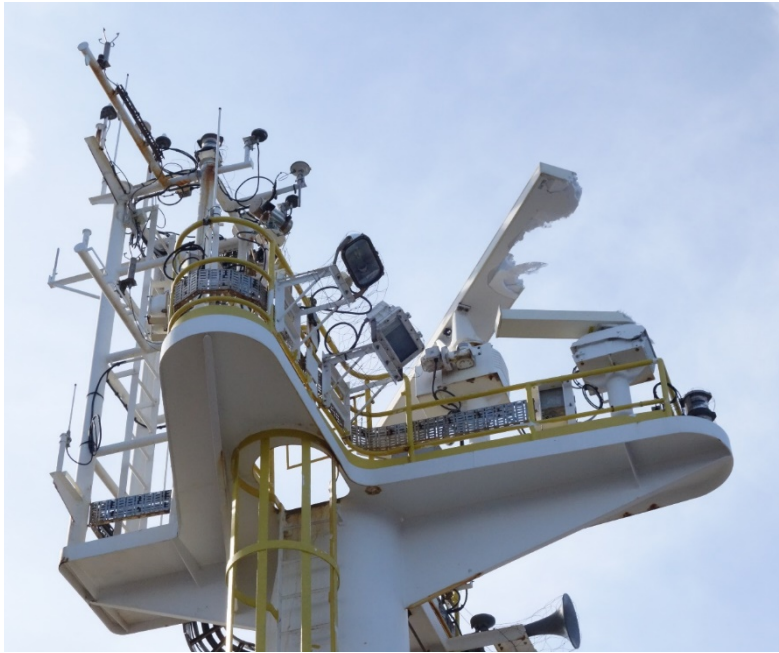
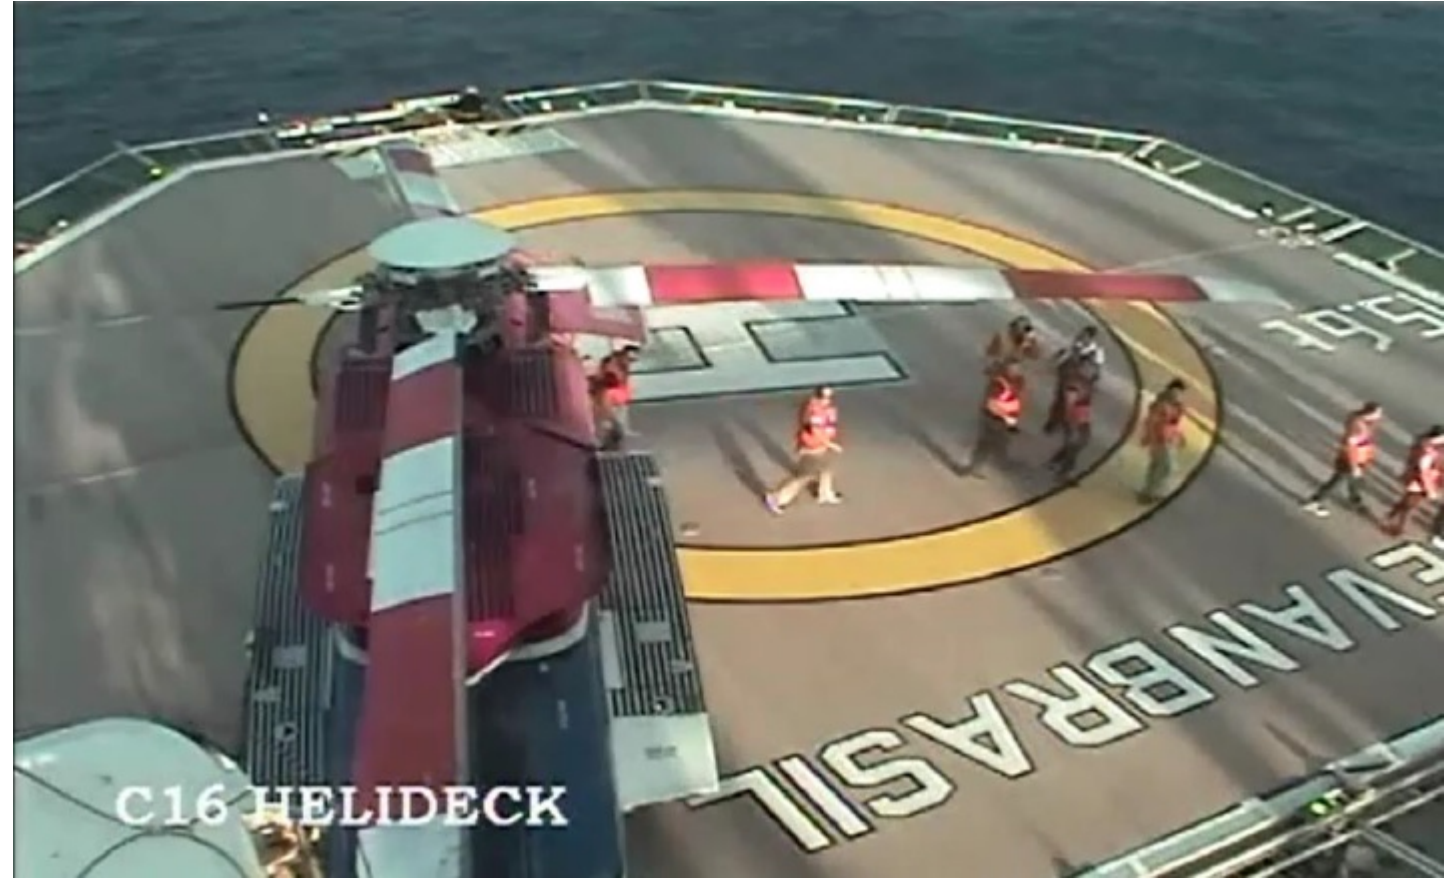
April 16, 2017: PR-CHR

- Vessel: Sevan Brasil
- NAA certified helideck, D-size 23m
- T/R impact on two rotating radar antennas
- No victims

**The tail rotor hit an obstacle because
the helicopter was not entirely within
the Obstacle Free Sector**
