## Technical Visit to Tai Shue Wan Site Formation Works

By Ho Cheuk Wing Samantha

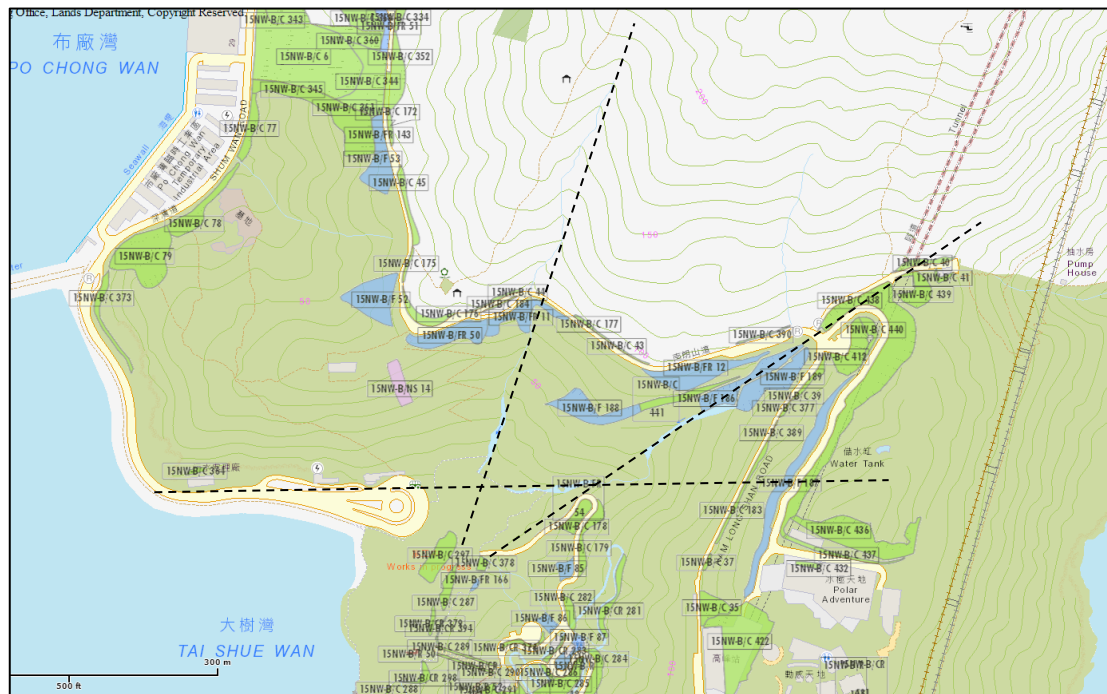
There are few photo-lineaments were identified at the area (**Figure 3**). Two northeast-trending photolineaments have been mapped which coincide with two small valleys and some outcrops around the area was sheared. One trending in E-W direction was mapped along the coast and the slope angle of the hill was steep.

**Figure 3: Approximate locations of photo-lineaments at the Site**
