Big Pipe Big Savings For Westlake, Ohio

By Angus W. Stocking, L.S.

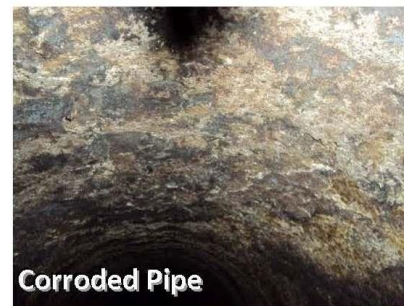
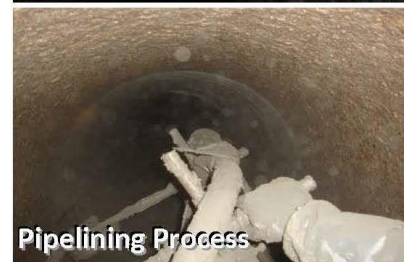
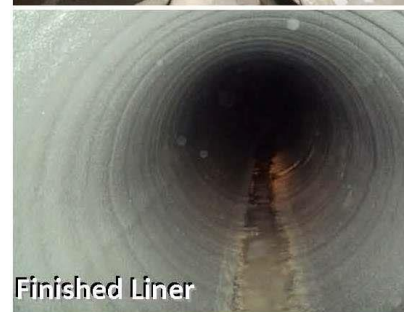
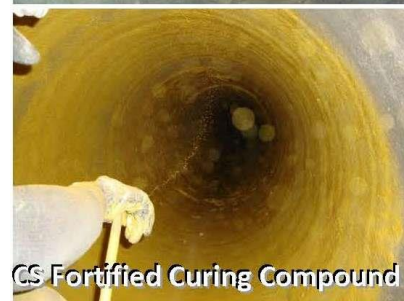
"When we inspected at year 40," says Westlake Field Engineer James J. Smolik, PE, "we televised the lines—everything was in good shape." But five years later, URS found significant MIC damage. "We could walk inside the interceptor and chip away concrete," Kelly says, "it was a real problem." MIC had eaten away 1/2-inch to 1 1/2-inches of the concrete pipe's inner surface. "And," says Smolik, "since the pipe thickness is only six-inches, we knew we had a problem."

There was *some* good news. According to our findings, MIC was confined almost entirely to within 25 feet of trunk line entry points. So, conceivably, Westlake could save money by focusing on problem areas and by leaving the rest of the interceptor alone. In theory, this would save about half of the cost of cured in place pipe (CIPP) rehabilitation, because the overall footage of rehabilitated pipe would be reduced by more than half. "We actually did a whole design based on that idea," says Kelly.

Contractors diverted flows around individual trunk line entry points by using 12-inch pumps to move waste overland. The pipe area that was subject to rehabilitation was cleaned and scoured with a high-pressure spin washer to remove loose material. As a final step before applying new grout, Westlake designers called for a Con^{mic}Shield® rinse of the cleaned interior to be certain MIC could not develop behind the new liner.

After analyzing the interceptor’s interior diameter, water load, extent of damage and other factors, engineers determined that a half-inch liner of PL-8000 grout with Con^{mic}Shield® would be optimum. This would repair and strengthen the interceptor, and prevent corrosion while preserving flow characteristics.
