Miami-Dade Specifies Con^{MIC}Shield[®] for New Manholes and Pipe

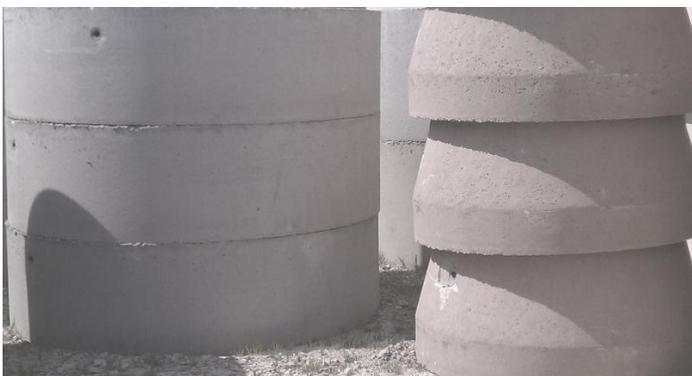
Precast barrel and cone sections with Con^{MIC}Shield[®]

In August 2001, a precast manhole was installed on Harbor Drive in Key Biscayne, Florida, called manhole #40. This manhole was fortified with Con^{MIC}Shield[®] during the precasting process at the plant. Con^{MIC}Shield[®] is a revolutionary technology for the effective and economical prevention of *Microbiologically Induced Corrosion (MIC)* commonly developed in concrete sewer pipe and manholes. It inhibits the growth of acid-producing bacteria (Thiobacillus) that produce sulfuric acid. Con^{MIC}Shield[®] is an additive that easily can be added to the concrete mix during precasting. Unlike coatings or plastic linings, Con^{MIC}Shield[®] molecularly bonds to the cement particles. It cannot wash off, chip off, peel off, delaminate or pinhole!

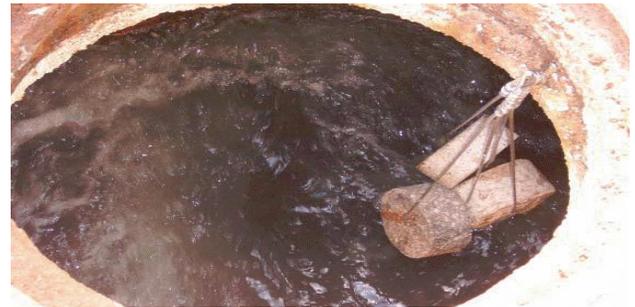
At the same time that Manhole #40 was installed, three test pieces of different mixes, all containing Con^{MIC}Shield[®], were attached to stainless steel cables and hung over the opening of the manhole. Over the five year period, the stainless steel cables were replaced several times but the test discs were unchanged.

Manhole #40 with suspended test discs

Manhole #40 was inspected in February of 2005 by a delegation that included Rodney Lovett, Chief of Miami- Dade Water and Sewer, Tom Adkins, American Cast Iron Pipe and Francisco Fuentes, P.E.

of the manhole found it to have served well in this highly corrosive environment especially since it is the first manhole out of a force main.

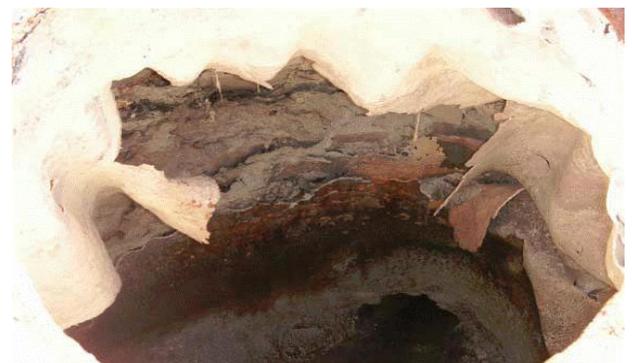
The manhole shown below is only 15 feet away from Manhole #40. The epoxy coating peeled off as shown below.

Nearby manhole without Con^{MIC}Shield[®]. Epoxy has delaminated.
