FILLING THE VOID

Beach town fixes failed storm drain

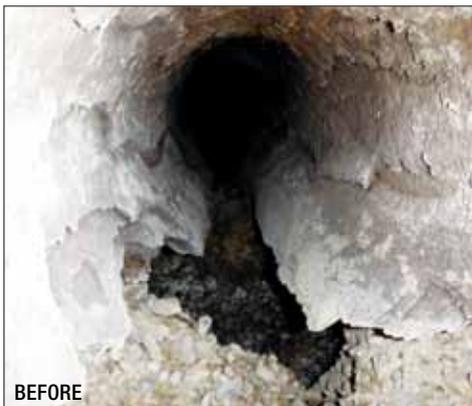
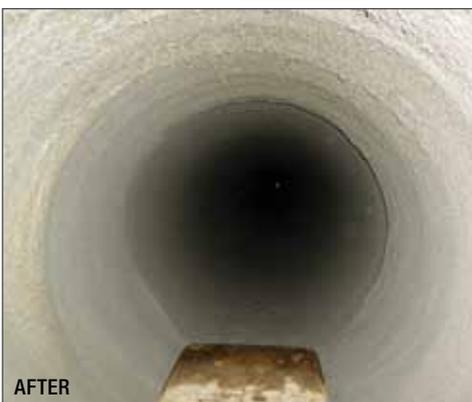
CIPP was used to line the laterals. “Big earth voids had formed around the lateral entrances,” Parsons said. “They were large, irregular cavities, and we weren’t sure how to fill those areas effectively.” New CIPP was placed in the laterals, and allowed to project well into the main storm drain. After curing, conventional grouting was used to fill and stabilize the voids around the projecting ends, and the lateral CIPP was trimmed to be flush with the main storm drain. This left a stable, round storm drain, ready for CCCP rehabilitation.

The CCCP rehabilitation process used, AP/M Permaform’s CentriPipe, is built around a precisely controlled spincaster that is inserted into a pipe and withdrawn at calculated speeds. As it is withdrawn, the spincaster sprays thin layers of high-strength cementitious grout that adhere tightly to most substrates. Essentially, it casts a new concrete pipe within the failing pipe that is completely sound structurally, with no seams or joints. Because the new pipe is cast in thin layers, impact is low during each pass, and because the final casting creates a structurally sound pipe with engineered thickness, the failing pipe is not needed for support. As the new concrete adheres tightly to the original pipe, no annular space is created for water flow outside the rehabilitation. The installations are usually quite thin—less than 2 in.—so flow capacity is not significantly affected.
