Still Going Strong 17 Years Later: Successful Sewer Structure Rehabilitation

Project combines Permacast® with Con^{MIC}Shield® to Repair AND Prevent Damage from MIC

Drop Shaft Details

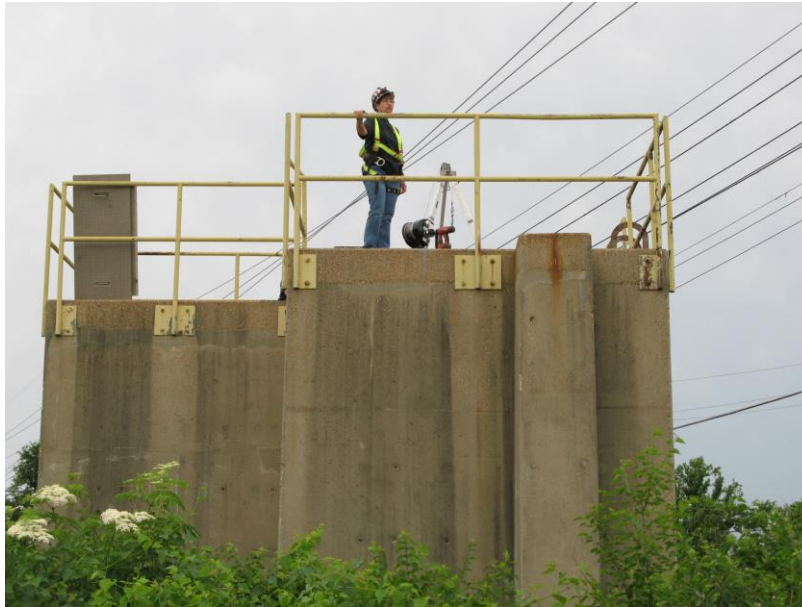
The results were dramatic. The upper portions of the shaft had

been eaten away about two inches, and surface layers were mushy. Toward the bottom, more than five inches had been eaten away, walls were mushy, and supporting steel was exposed and corroded. Quite literally, this was a disaster waiting to happen.

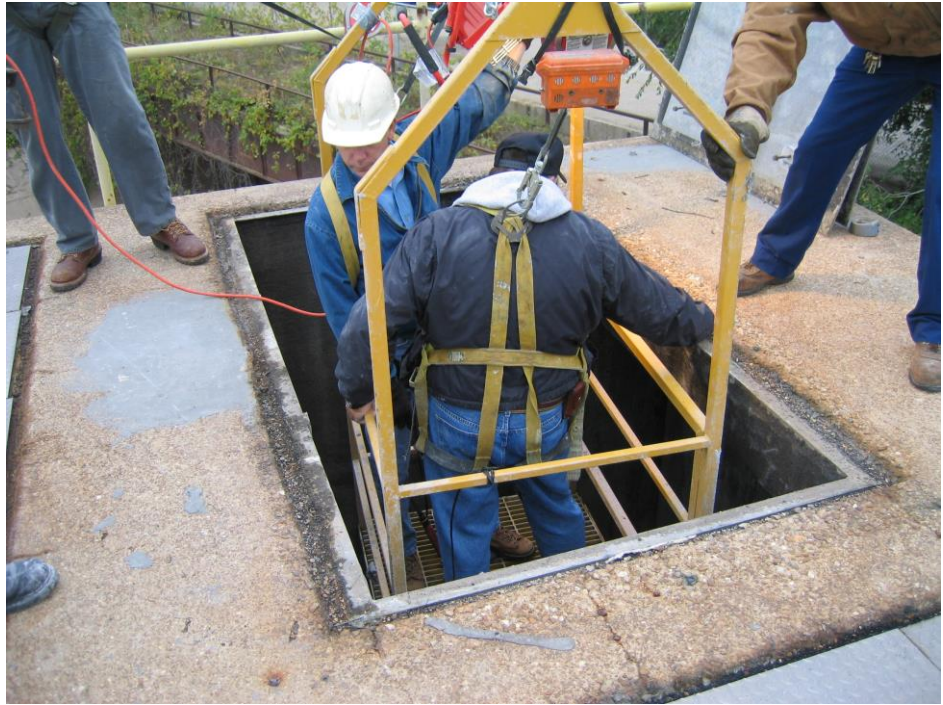
- Power washed the walls back to solid material
- Installed wire mesh to the walls for structural reinforcement of the worst areas

- Applied several one-inch layers of MS-10,000, a high-strength cementitious grout developed by AP/M PERMAFORM and fortified with Con^{MIC}Shield®
- Troweled the surface after each layer was applied to ensure a densely-compacted, uniform finish
- Troweled smooth a final one-inch layer once the entire wall was rebuilt to the plumb line

And basically, that was it. The drop shaft looked like new with smooth walls, and it didn't matter that we reduced the inner dimensions by one inch—the Maline Drop Shaft still has plenty of capacity.
