Technical Visit to Natural Terrain Hazard Mitigation Works at Sham Tseng San Tsuen

AGS(HK) organized a technical site visit to a natural terrain site behind Sham Tseng San Tsuen on 1 March 2014.

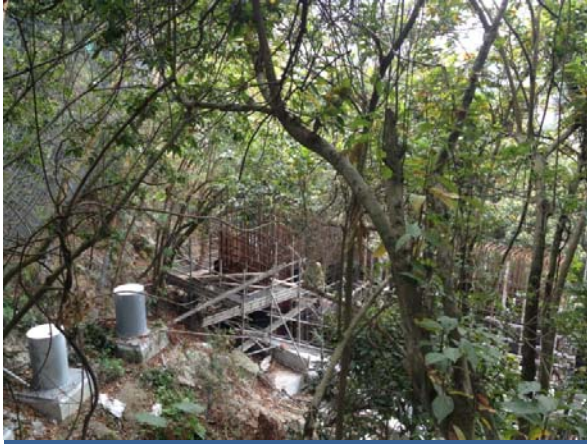
Construction of concrete baffle, concrete check dam and flexible barrier fence at steep terrain

The attendees were able to view the ongoing construction of circular concrete baffles, soil nailing works, concrete check dam and flexible barrier fences on site. Furthermore, construction planning and good site management are particularly important in order to overcome site constraints particular to NTHM such as remoteness of the site, and limitation of space in carrying out the works on the steep hilly terrain.

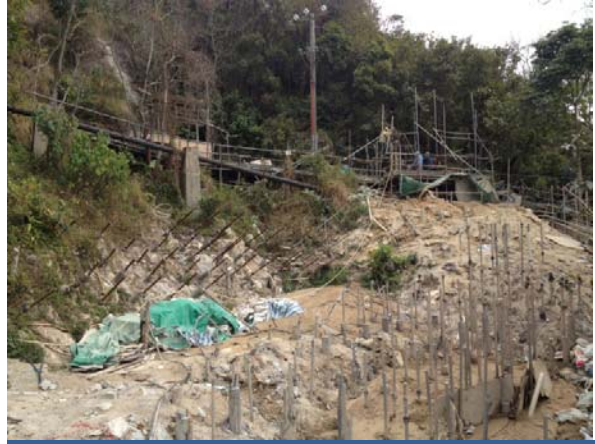
Installation of soil nails instead of mini piles to resolve the site constraint with limited space
