CHC SAFETY & QUALITY
summit
DALLAS 2019

LOOKING AT THE RIGHT PLACES FOR HELIDECK SAFETY

Fernando Moraes and Morne Wiid

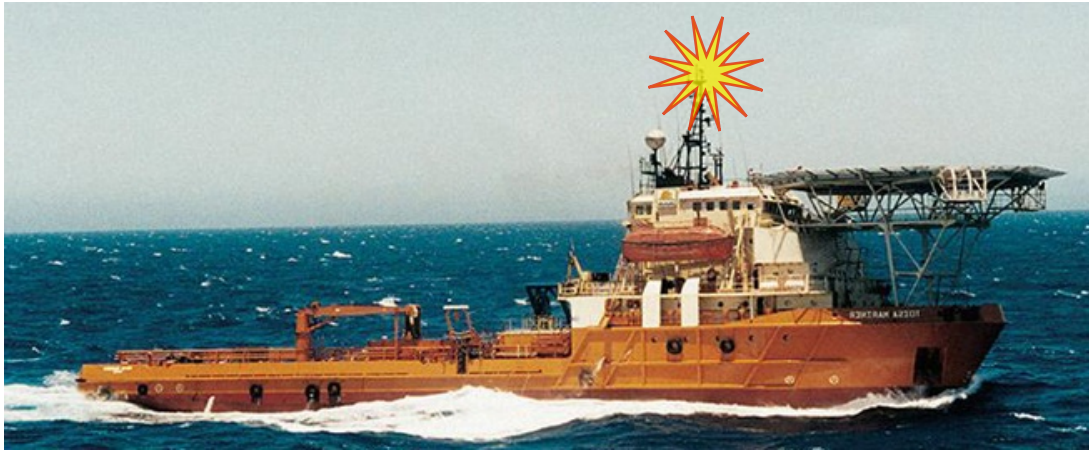
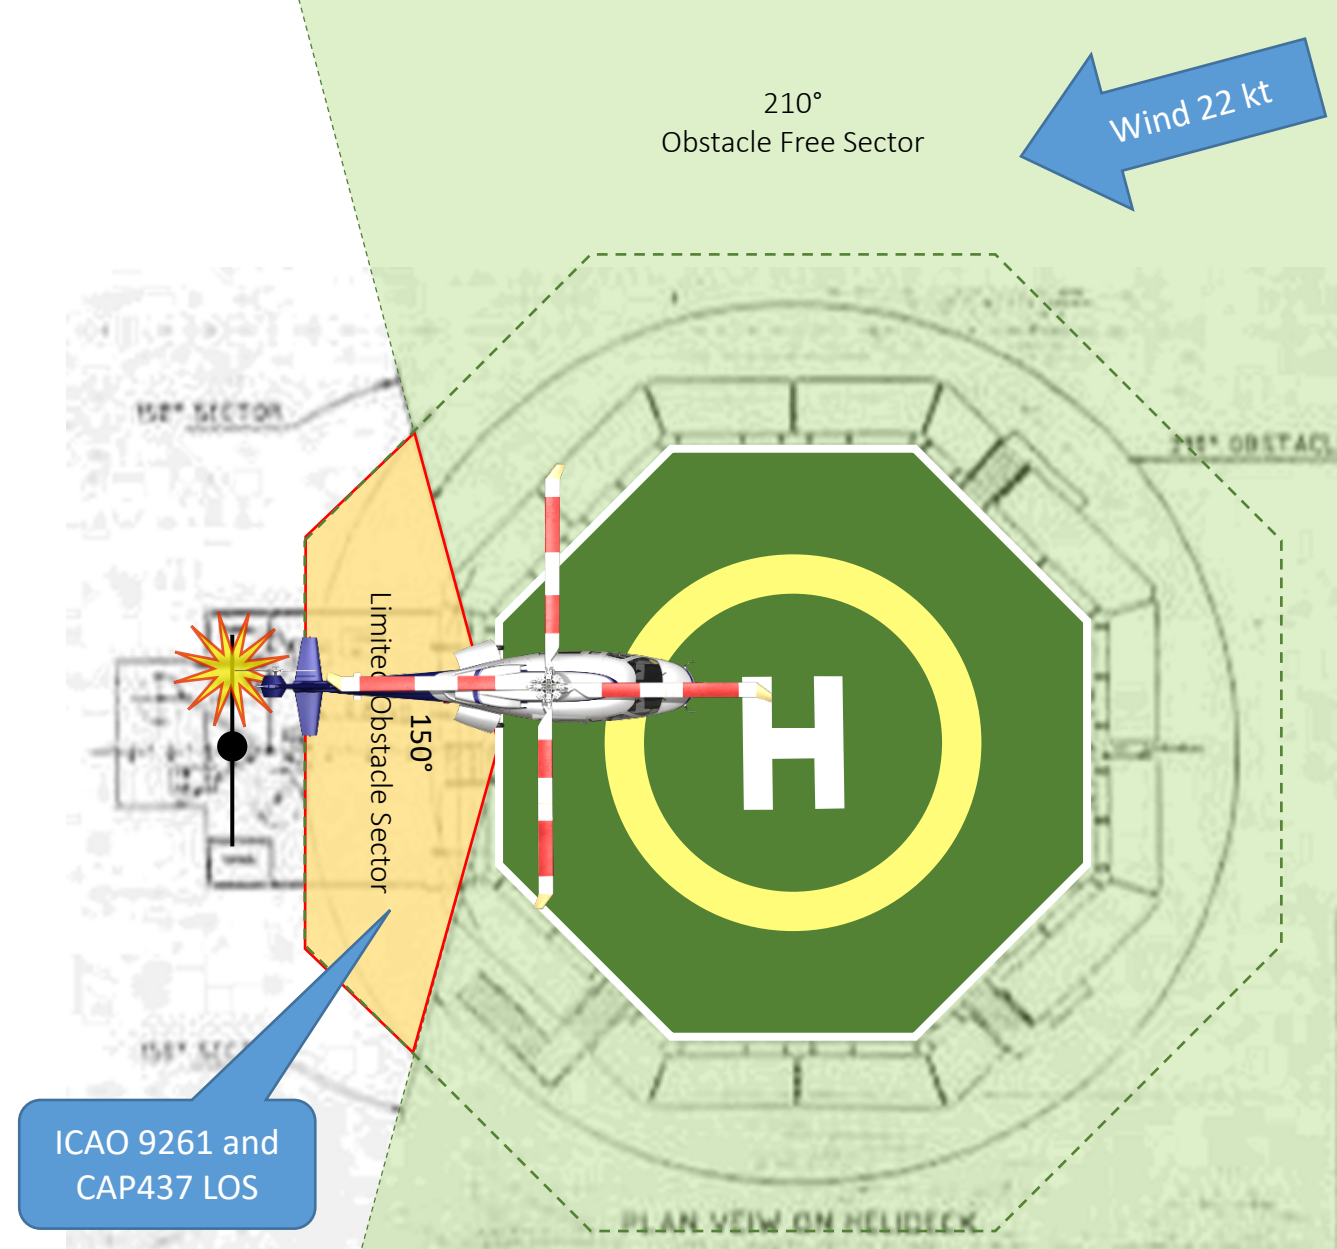
July 5, 2003: PT-YVM

- Vessel: Toisa Mariner
- NAA certified helideck, D-size 17,5m
- T/R impact on the yard of a mast outside the LOS, 8m high
- 5 fatal victims, no survivors

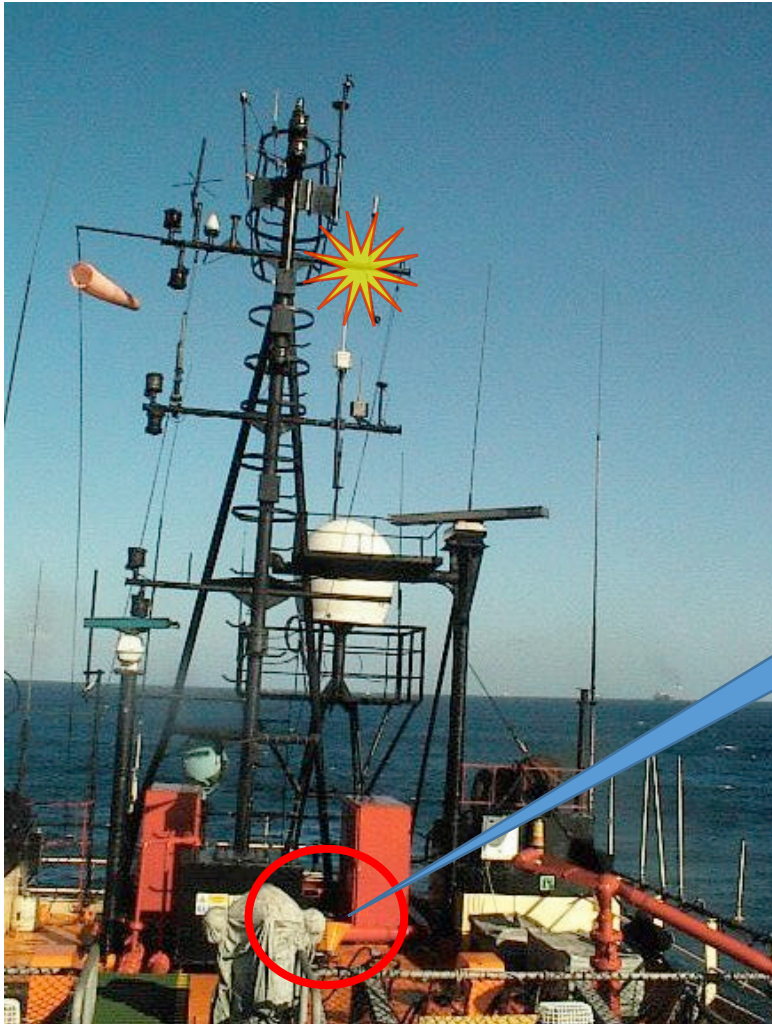
Part of TGB
that departed
the fuselage

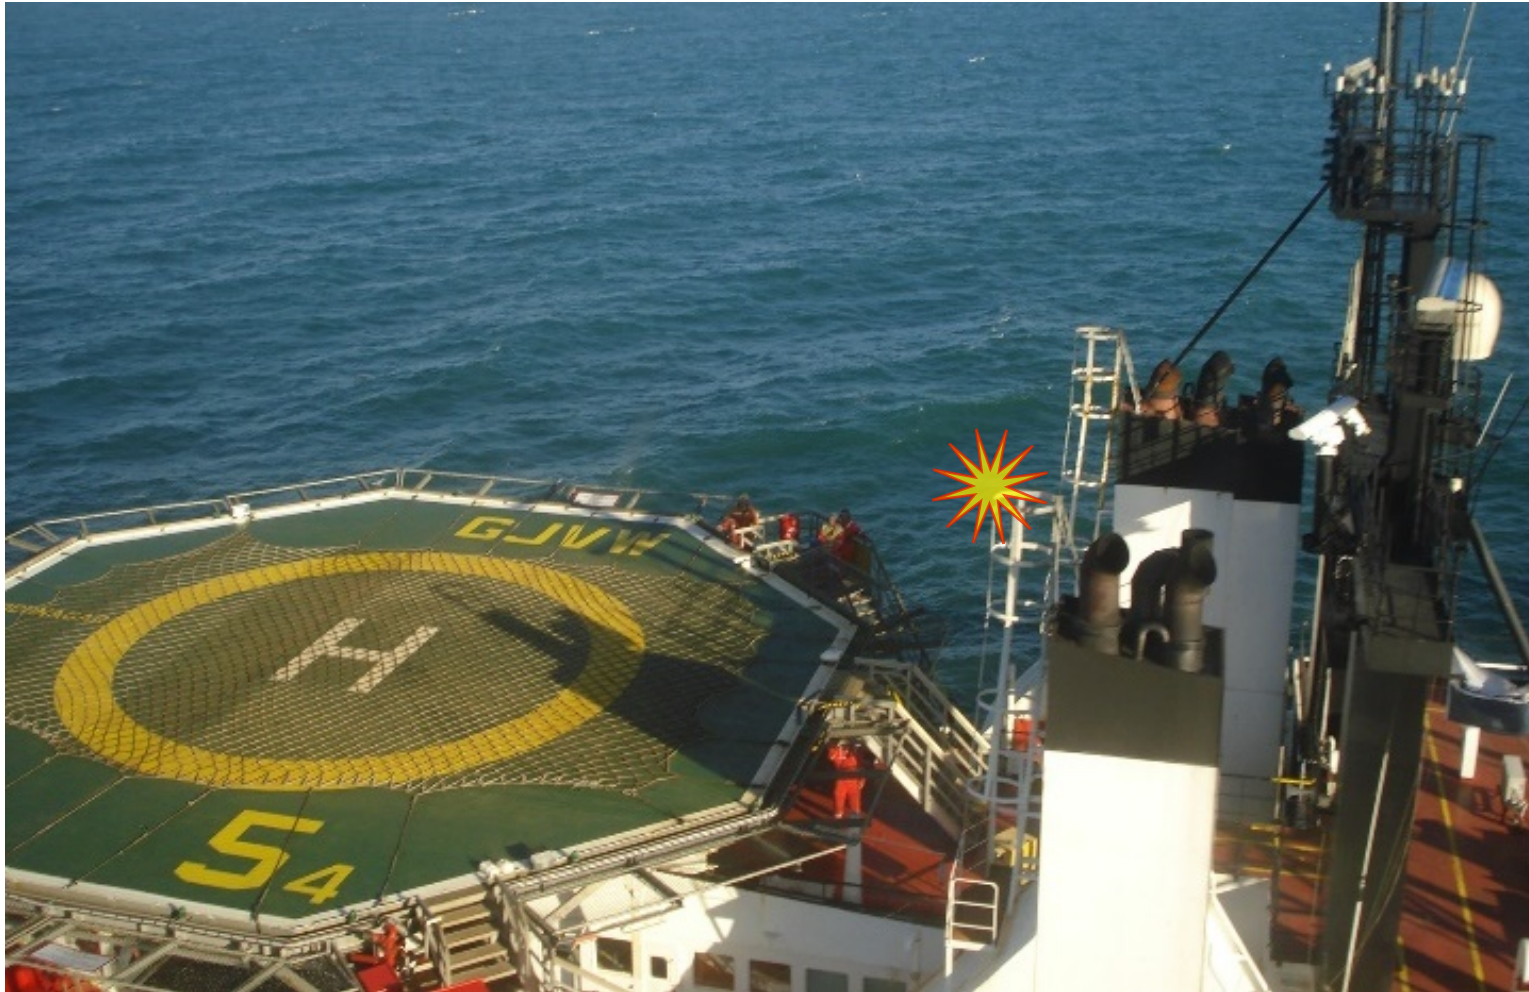
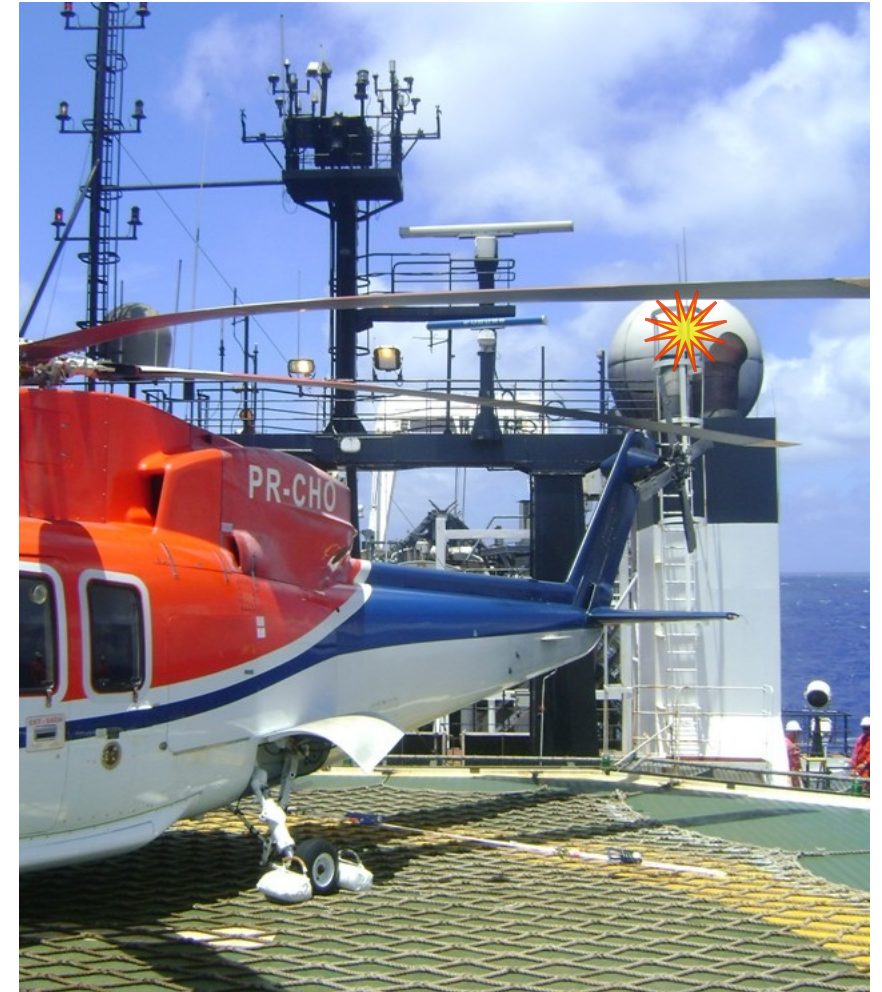
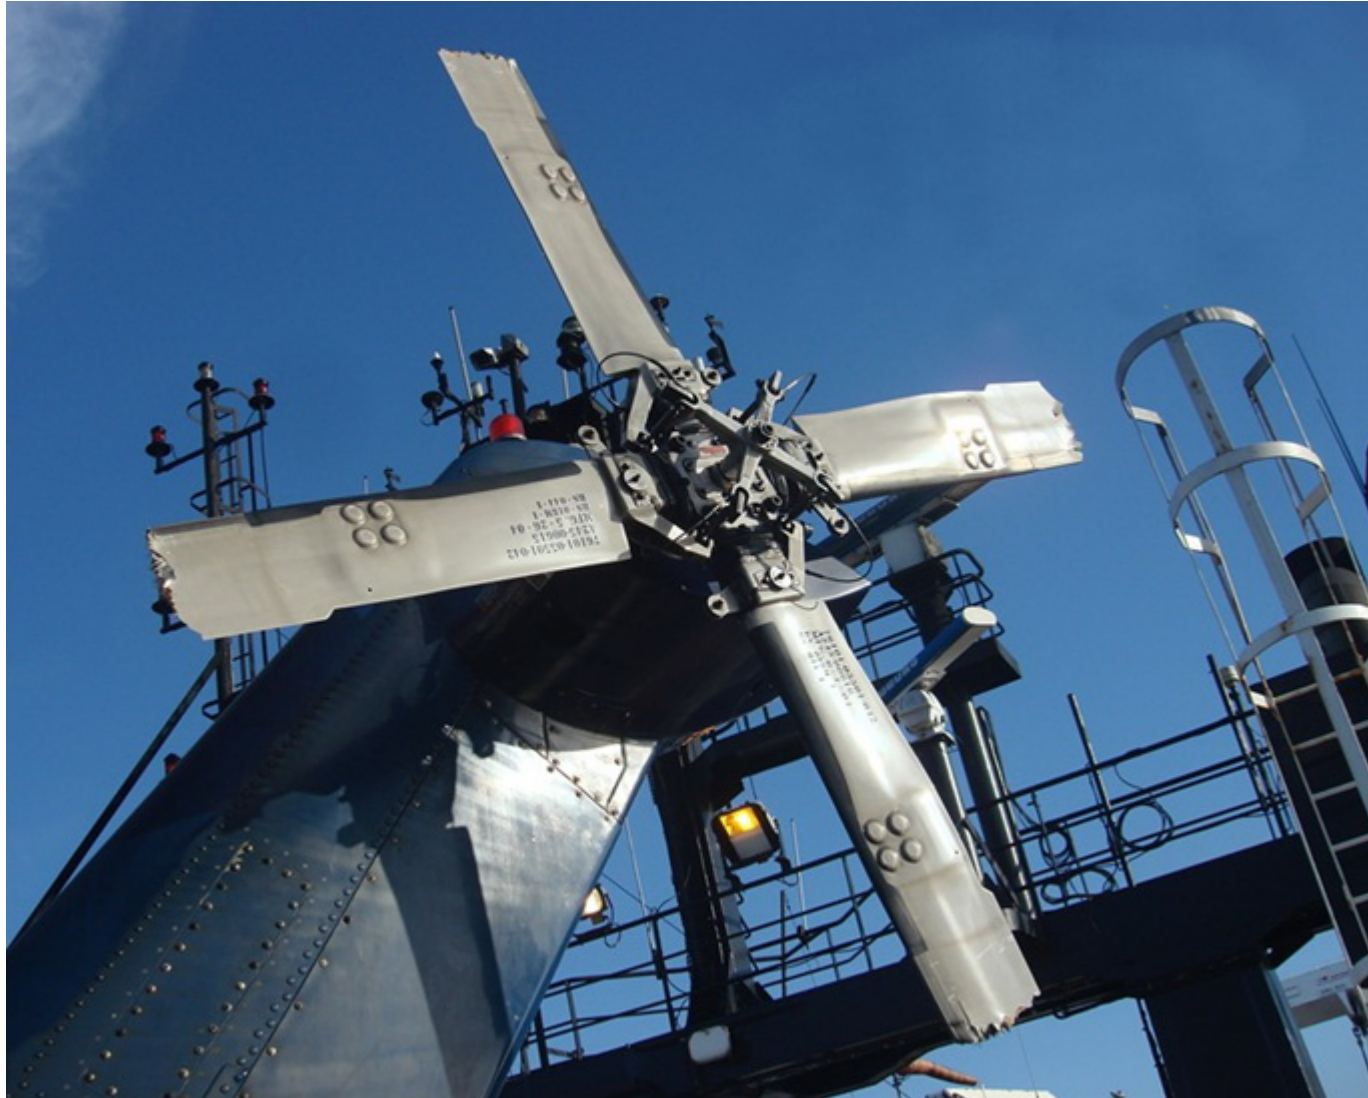
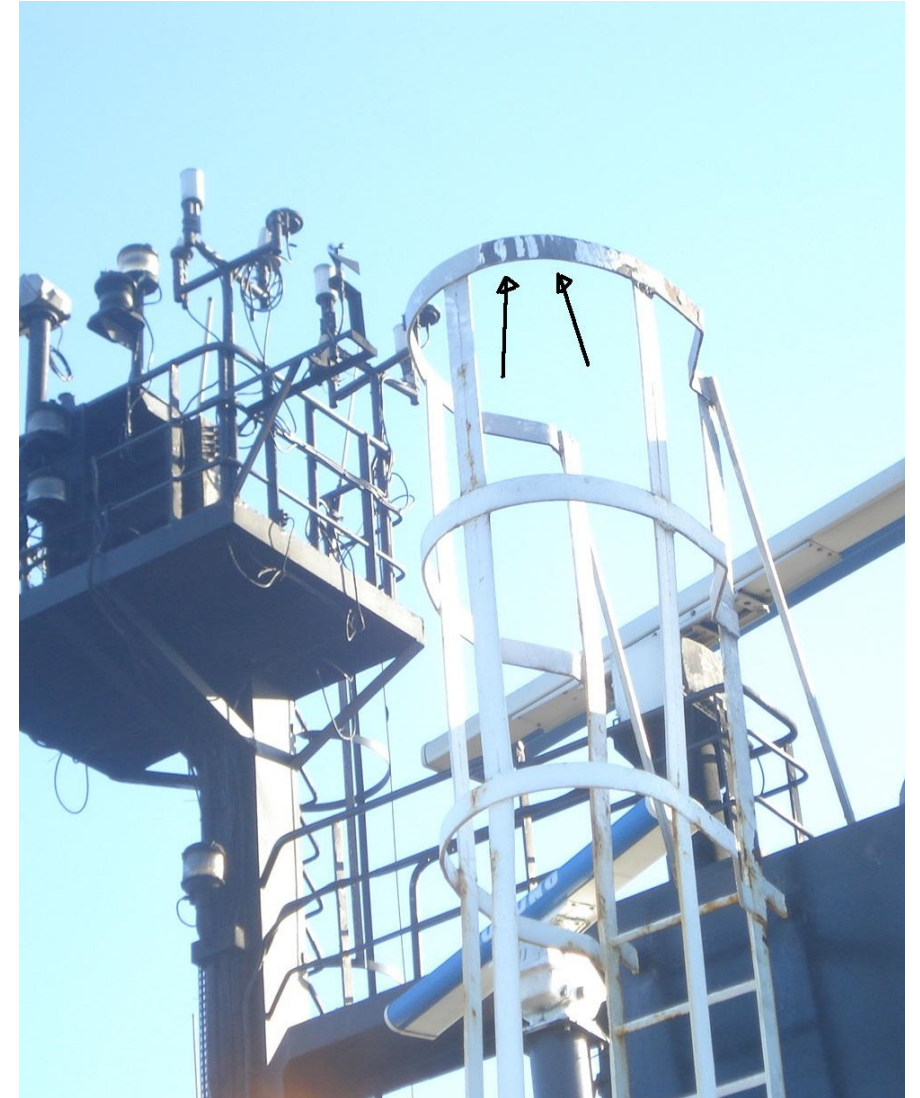
July 2, 2012: PR-CHO

- Vessel: Lochnagar
- NAA certified helideck, D-size 17,5m
- T/R impact on the top of the safety railing of a ladder attached to a smokestack, outside the LOS
- No victims

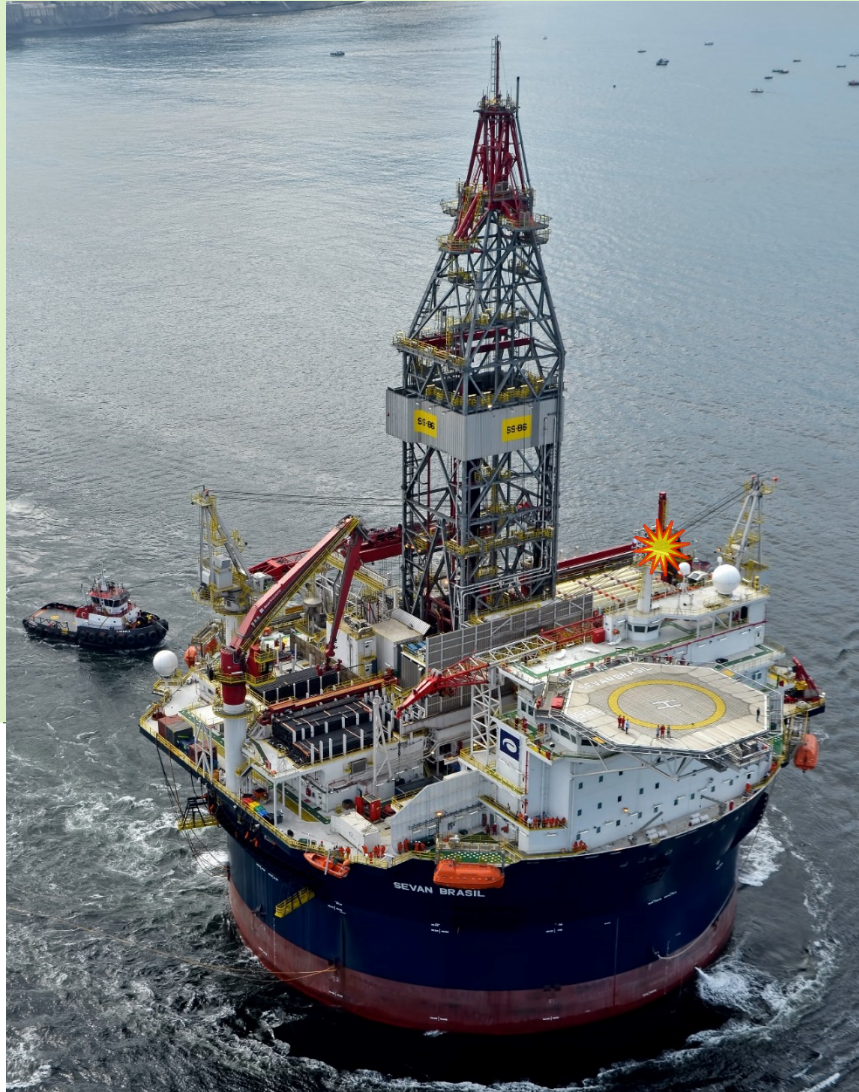
April 16, 2017: PR-CHR

210°
Obstacle
Free Sector
(swung 15°)

- Vessel: Sevan Brasil
- NAA certified helideck, D-size 23m
- T/R impact on two rotating radar antennas
- No victims

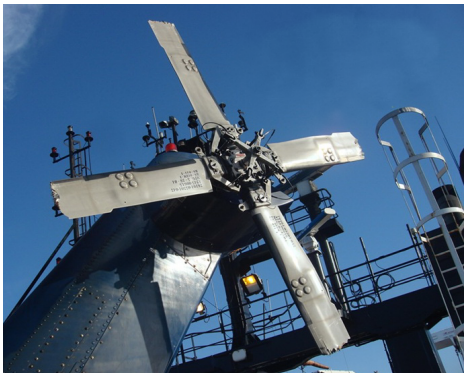
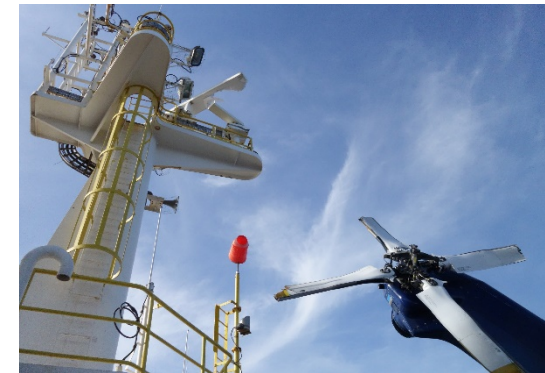
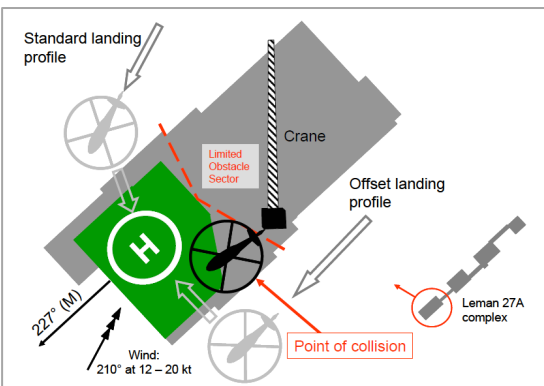
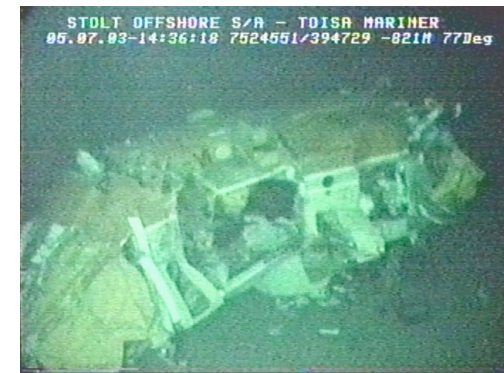
**The tail rotor hit an obstacle because
the helicopter was not entirely within
the Obstacle Free Sector**
