Basca washing machine to clean IBC's dirty of water treatment chemicals

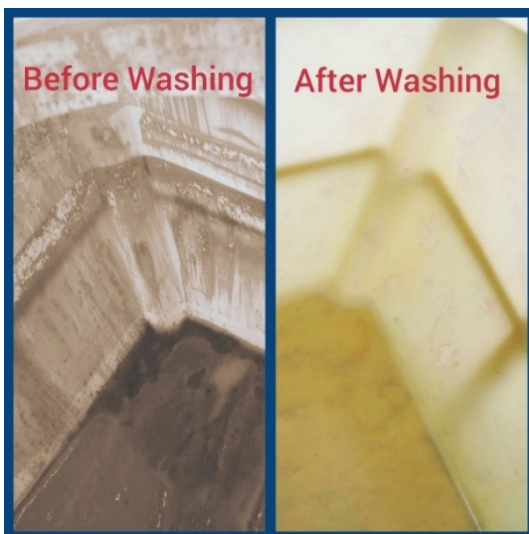
Basca supported the client to analyze facts and figures of his situation, suggesting possible solutions to wash the IBC's in automatic, enviro friendly and safe way. Then a washing test at Basca facilities has been done to find the most suitable machine configuration. Once the desired machine configuration has been finalized, we have supplied a Basca Washing Machine equipped with a 200 bar pump to spray the water on the tank surface granting a perfect cleaning in about 5 to 8 min/IBC.

The operator brings the dirty IBC to the machine, selects the program in the control panel, brings down the washing head and starts the cycle.

The washing head starts its rotation and contemporary spray of the washing water in recirculation at 160 Bar 70°C. The washing machine has 3 different programs, Eco Wash, Normal Wash, Intensive Wash, that can be chosen according to the type of product to be washed away and dirt.

At the end of the washing cycle, the machine automatically switches to the rinsing mode and injects clean water into the system. Rinsing water is sucked from the wastewater treatment stocking tank.
