## In The Underground

*Indiana city saves critical brick storm sewer by going trenchless*

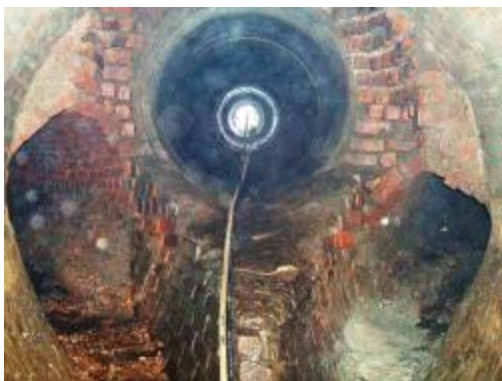
There were issues with the bottom of the 48-in. storm sewer pipe, as well as cracks running along the length of it.

The Warsaw rehabilitation took about five weeks total, but work with the spincaster was only about one week. First the pipe was plugged and dewatered, and the bottom was sealed with underwater cement due to greater-than-expected inflow and infiltration; this also provided a smooth bottom surface for the spincaster sled to travel on. Long cracks were sealed with MS-10000, a fiber-reinforced cement from AP/M Permaform.

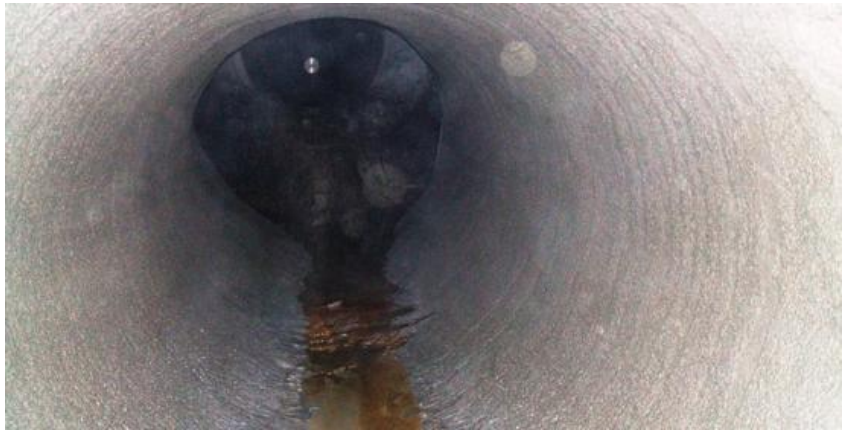
**The rehabbed pipe is waterproof, smooth and relatively thin, so flows are not restricted.**

After plugging holes, filling cracks, stabilizing loose brick and cleaning the pipe with high-pressure jetting, PL-8000, an AP/M Permaform cementitious grout designed for brick and concrete pipe relining, was applied in two passes of about ½ -in. each.

Application thickness is controlled by adjusting the withdrawal speed according to the project requirements. To verify layer thickness during application, a thin-wire wet gauge is inserted into the grout at random points for precise spot checks of actual applied thickness. Bag counts (of PL-8000) are kept during passes to keep track of applied volume and are compared with calculated volumes for the exact pipe lengths.
