Centrifugally Cast Pipe Repair Resolves Storm Sewer Challenge

By Angus W. Stocking

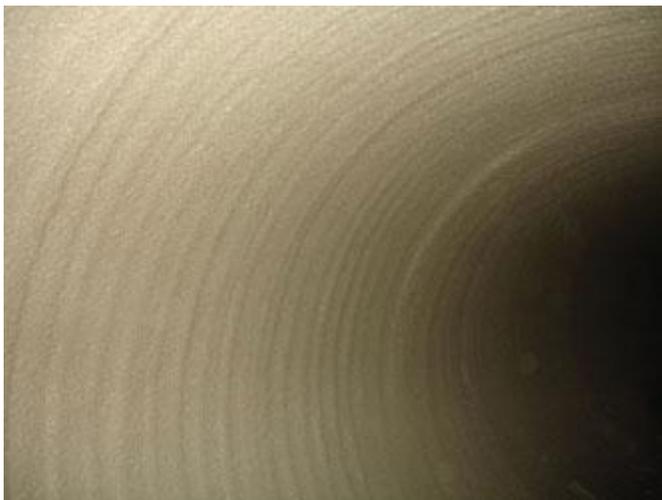
Three passes were required to complete the lining project. The result was a clean pipe that only reduced the sewer's inner diameter by 2.5 inches.

With prep work done, the Otay Landfill project became a straightforward CCCP project. The AP/M Permaform crew worked from riser to riser, with a longest pull of about 150 feet. A total of three layers were applied, for a total thickness of 1.25 inches. When working with CMP, as on this project, special effort is made on the first layers to "flatten" the corrugations; this way, the final layer is uniform and smooth.

With prep work and three passes, total time on site was eight days. The result was a clean, strong, rustproof pipe that only reduced the sewer's inner diameter by 2.5 inches.

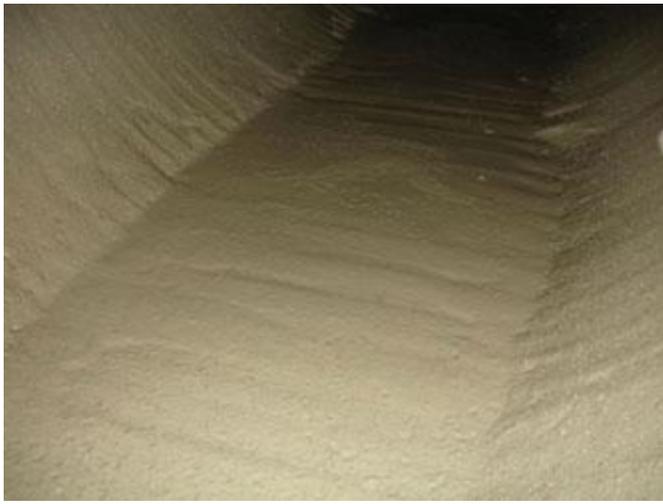
Rust had nearly destroyed much of the invert. Eroded voids were filled with sand and grout, and a new grout invert was poured.

storm sewer, that required filling of the eroded voids with sand and grout, and the pouring of a new grout invert.

PL-8000, made by AP/M Permaform, was used for the invert and the spincasting. The product is a cementitious, fiber-reinforced mortar with excellent properties for CCCP including high strength, quick curing, adherence in moist conditions, and resistance to rust and corrosion.
