CATCHING UP ON CULVERT REPAIR

Oregon Department of Transportation tests trenchless solution

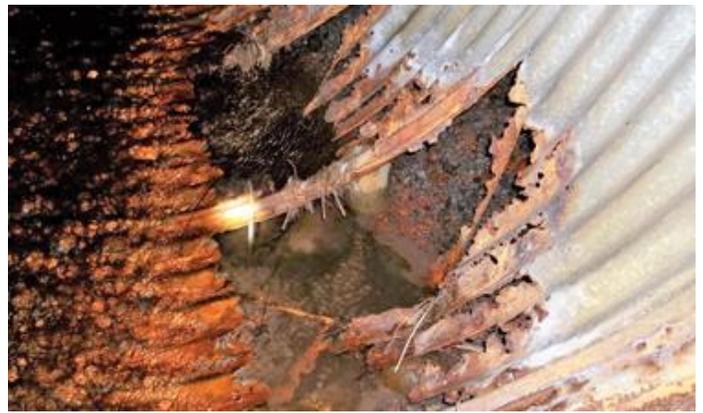
“When we actually got in the pipe and took a look, we found that it was worse than we thought,” Gunther said. Inverts were near failure or completely rusted out, and large voids were visible behind rotten patches for most of the culvert’s length. Oregon’s famous storm events also took a toll; rocks and sand pushed along by occasional high-velocity flows had damaged the CMP.

Before rehabilitation, the corrugated metal pipe showed signs of physical damage due in part to storms and debris pushed through by high-velocity flows.

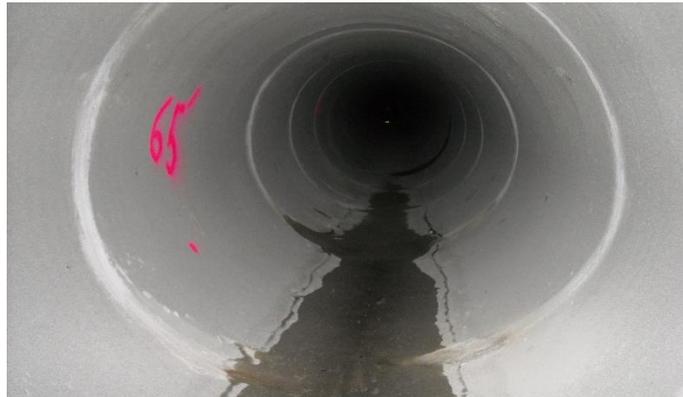
Rehabilitated pipe is smooth, seamless, structural, and watertight

SunCoast set up on a patch of ground, about 20 by 8 ft, by a drain near the middle of the culvert. This highlights another advantage of CentriPipe; staging areas are relatively small, compared to competing solutions. By inserting the SpinCaster in the middle drain, SunCoast was able to work from the ends of the culvert to the drain. Two passes were required, each laying down a 0.5-in. layer.

gauges and by keeping track of volume of material applied. On this project, SunCoast applied two layers, and total thickness was an inch above the CMP corrugations. Due to the infiltration issues, total time on site was almost a month, but actual spray time was just more than a week.
