40 FEET DEEP & ABOUT TO FAIL – TOMHANNOCK RESERVOIR NY

A complex pipe repair in New York's Tomhannock Reservoir

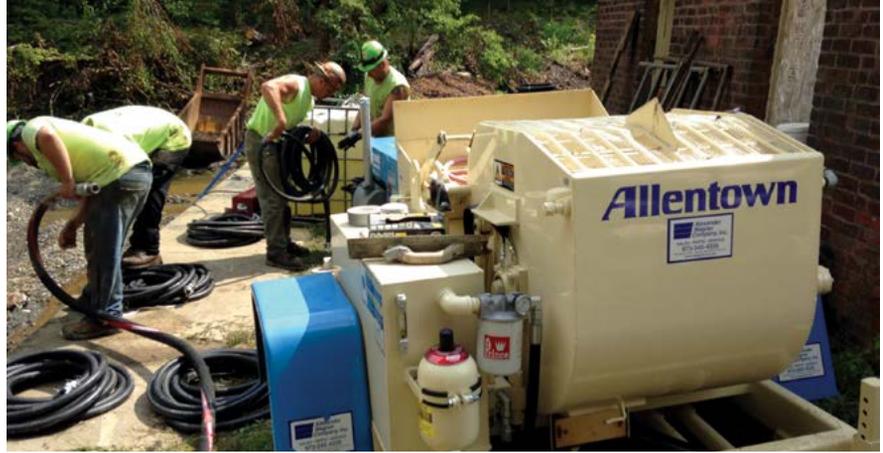
The minimal staging area required made CCCP technology an ideal solution for this project

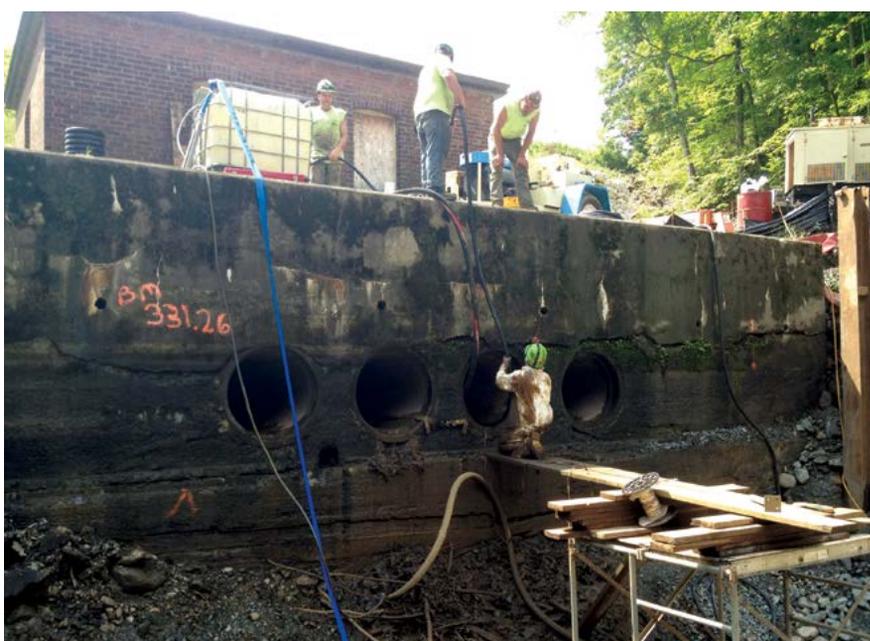
Power air and concrete hoses were run through the 30-inch diffusion pipes

The minimal staging area needed, in particular, was key for the Tomhannock project. Arold realized that he could set up the spincaster's withdrawal winch in the diffusion chamber and run in power, air and concrete hoses from outside the dam and through the 30-inch diffusion pipes.
