DEC 13, 2017

NEW YORK COUNTY REHABILITATES SANITARY SEWERS

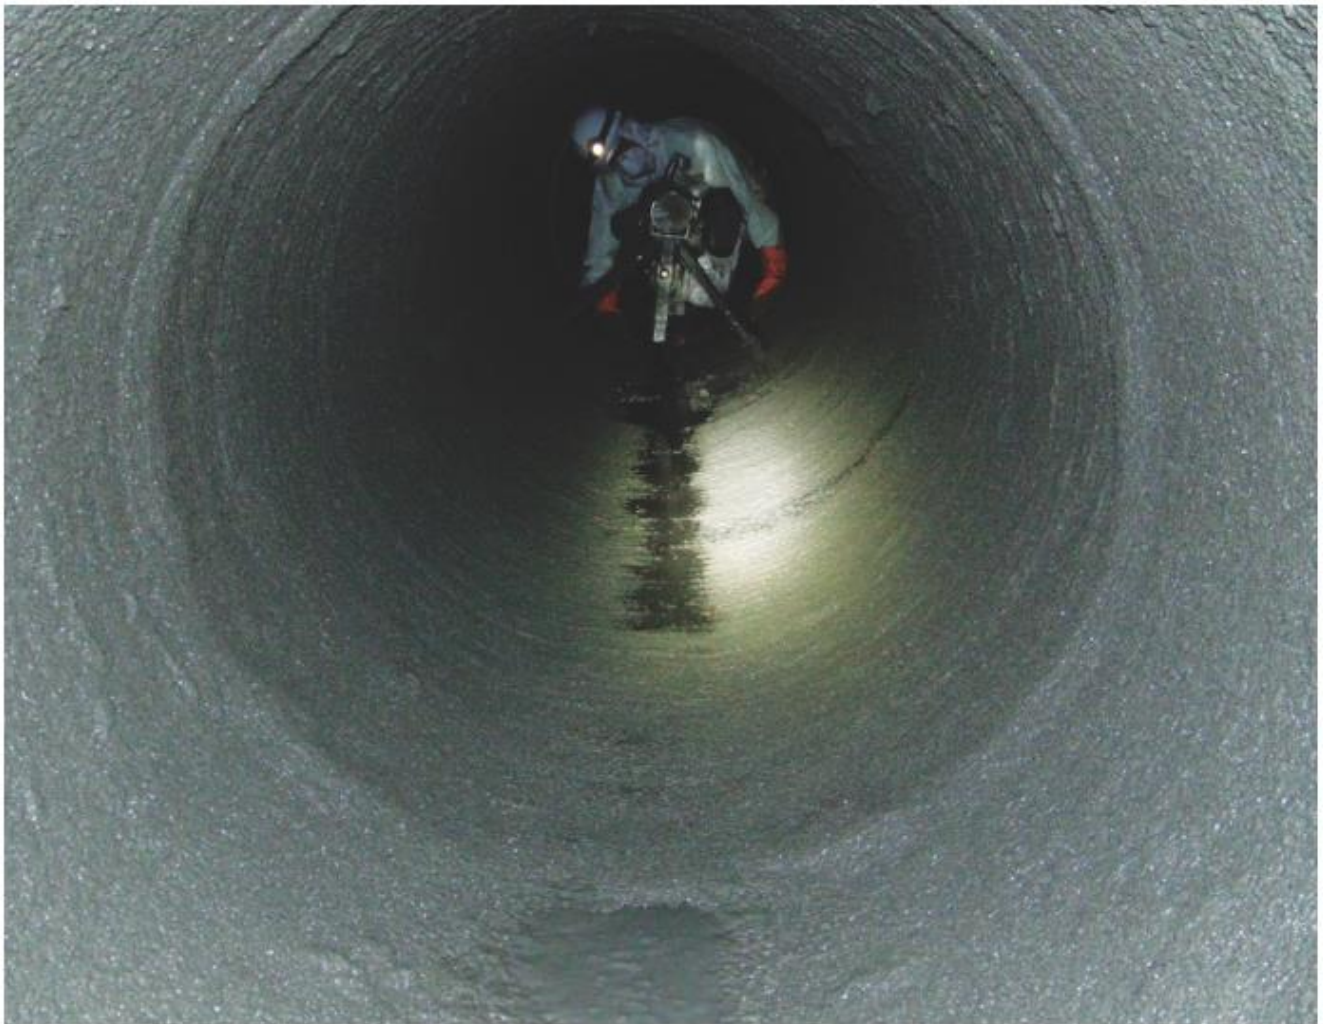
Rockland County in southern New York called for major sanitary sewer interceptor projects. The county has completed its second project, which required rehabilitating a failing sanitary sewer interceptor and pipes using cost- and labor-efficient means without disrupting rail or the New York state highway traffic overhead. In addition, the project aimed to prevent future microbiologically induced corrosion.

Finally, crews discovered a 10-ft collapsed section of pipe and an adjacent sinkhole. This required stabilizing the pipe and centrifugally casting fine aggregate cementitious composite for structural rehabilitation.

Had the team planned to dig under the tracks and the state highway, the project would have been much more difficult and costly. Instead, centrifugally cast concrete pipe offered a more efficient approach to repairing the sanitary sewer.

The defects in the pipeline were addressed and repaired with minimal impact to property located above. Rail operations were not affected, and no detours were needed on the highway. According to Nuzzie, inspections have shown that the centrifugally cast concrete pipe has good adherence and is in good condition.
