ODOT REPAIRS ARCHED CULVERTS FROM THE INSIDE

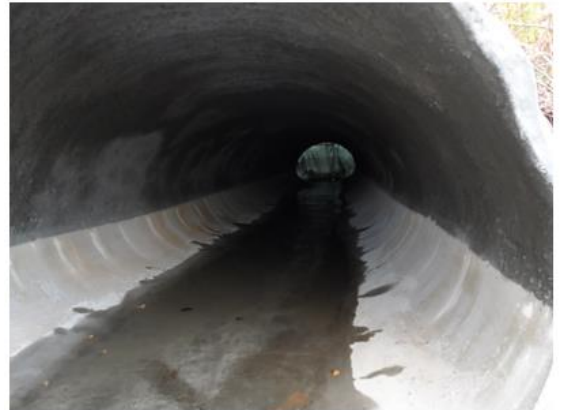
Often, only the inverts require repair initially. The Ohio Department of Transportation (ODOT) previously had repaired the inverts of two large culverts by paving them with concrete. Subsequently, the two culverts—12 ft 6 in. wide, 7 ft 1 in. tall, and running for 90 ft under a two-lane rural road near Cincinnati—showed significant rusting and leaking from the arched upper sections and required full structural repair.

ODOT selected CentriPipe to repair the two arched culverts. The centrifugally cast concrete pipe solution requires a minimal staging area and results in a smooth, watertight structural liner within the host pipe. To ensure the system met the design thickness, hundreds of self-tapping screws were set into the metal plate, protruding 2 in. above the culvert corrugations.

The new fine aggregate cementitious material was applied in several layers, each no more than 1/2 in. thick. The composition of the fine aggregate material cures quickly and bonds subsequent layers tightly, leaving no cold joints. The material, PL-8000, is engineered with an integral crystalline technology and provides waterproofing and autogenous healing as the fine aggregate cementitious liner continues to strengthen through ongoing exposure to moisture.

Using this system, sewer joints and inverts were repaired. Several passes were made through each culvert, applying thin layers of the material with each pass until a total thickness of 2 in. was reached, which resulted in a cost-effective, structural solution without traffic closures.
