Keeping the Trains Running: MuddRuckers Completes Challenging Trenchless Culvert Repairs for CN Rail

Fairmount Road - A Winter Project

Wilkes Avenue

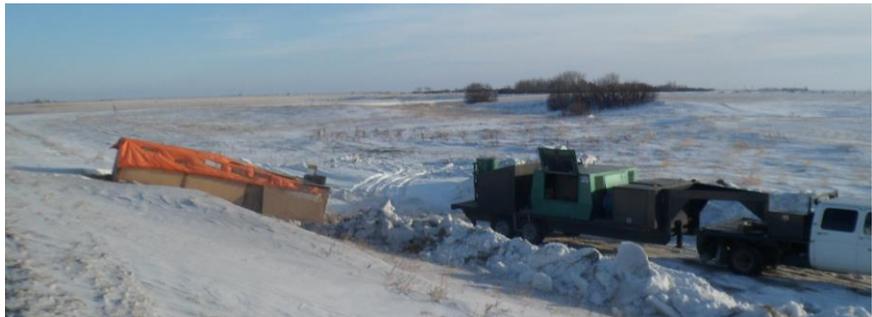
Enclosed heated and insulated workspace enables winter application of centrifugally cast, high-strength fine aggregate composite concrete rehabilitation material

4’x6’ and 4’x8’ panels, made of plywood and rigid insulation were used to build walls around the culvert ends, and the walls were covered with insulated tarps to create large hoardings. “This is a system that is fast and easy to put up,” Cook says. “And it’s flexible enough to match uneven grades.” With end enclosures in place, ground thaw heaters and hoses were introduced and left in place for a few days; this brought temperatures up in the existing

Once culverts are prepared, the actual CentriPipe work was straightforward. The hoarding around the work end of the culvert was greatly expanded to

enclose the heaters, water tanks, winches, and pumps needed to supply and withdraw the CentriPipe spincaster, and half-inch layers were applied on two successive days. Layer thickness is judged by the on-sited operator, who can adjust withdrawal speed as needed. In some cases, pins or screws are set in existing pipes for use as depth gauges, and total volume of applied material can be calculated from the amount of bags of material used. Here, as is typical, MuddRuckers applied PL-8000, a fine aggregate composite concrete from AP/M Permaform that is fiber-

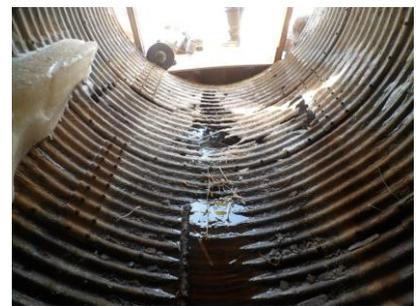
Another particular challenge of this project was the culvert condition. Though rusty, the CMP was mostly intact. However, the culvert was relatively clogged with mud and debris. After most physical debris was removed, MuddRuckers used a vacuum truck to remove mud and dewater the culvert, and completed the culvert preparation with scouring. In this case, the existing pipe was sound enough for spincasting to

Rusted invert of culvert prior to rehabilitation

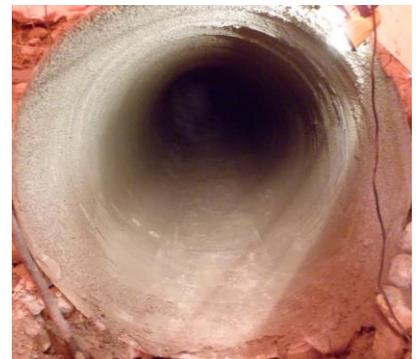
Structurally sound, water-tight, rehabilitated culvert

Total time on site was less than two weeks, which included clean up and several non-active days when heat was maintained to facilitate curing. Hourly rail traffic was never affected, and train activity did not affect any phase of the CentriPipe work.

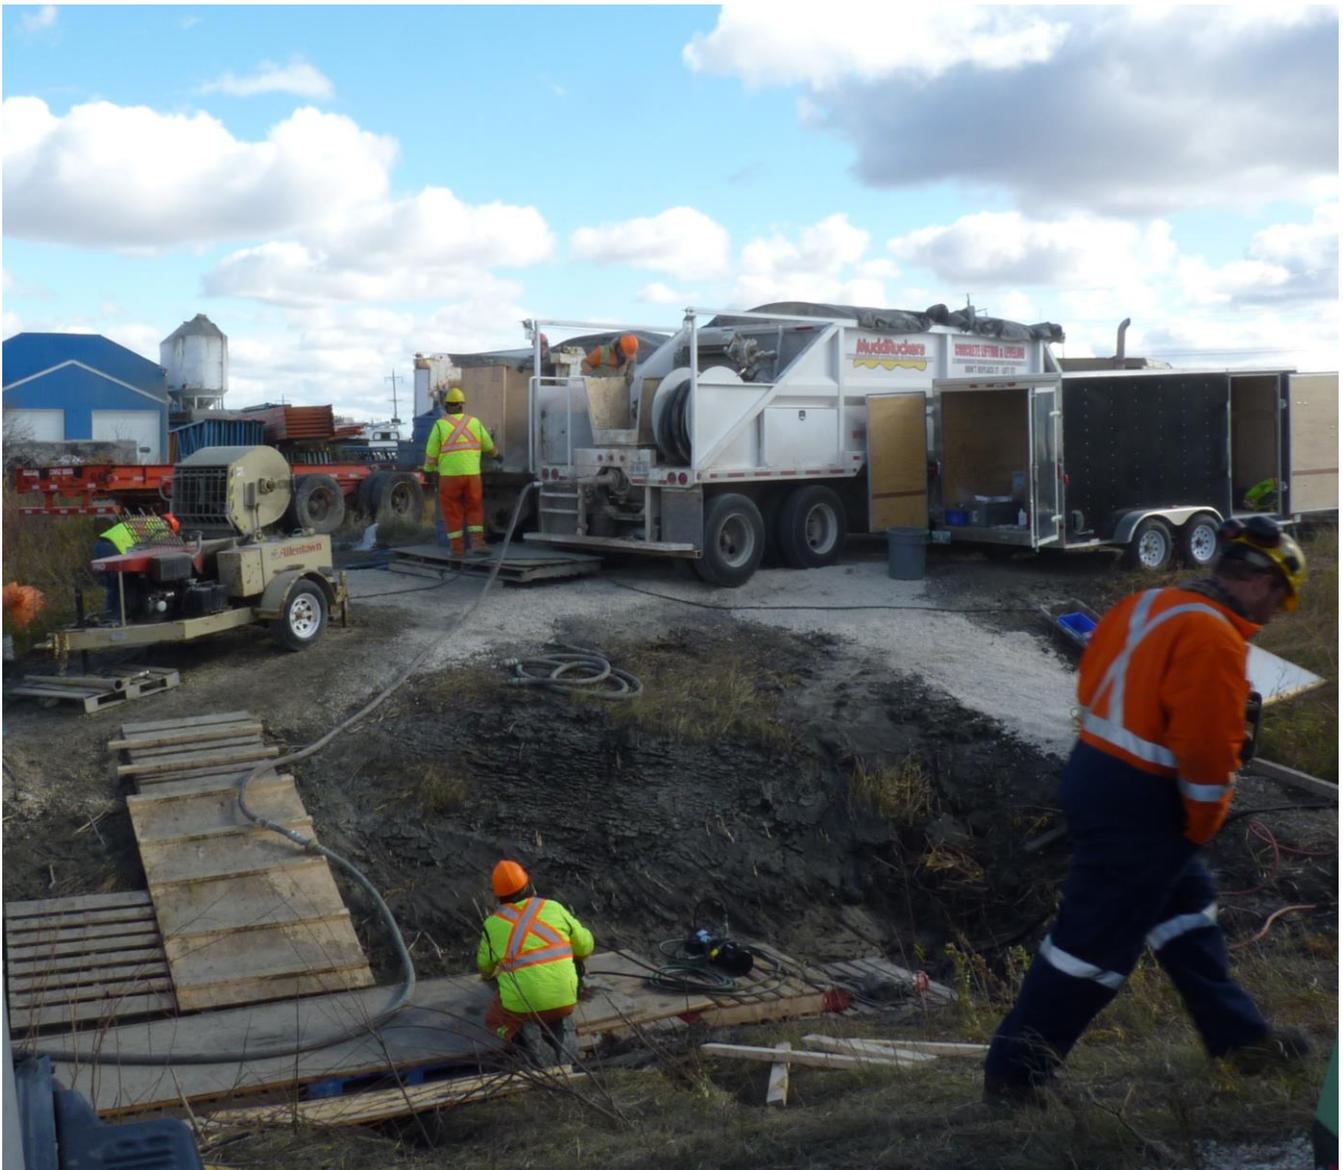
Site prep and staging included dewatering and a network of pallets to provide secure footing on the muddy terrain

Since the weather was warmer, and water wasn't freezing, dewatering was more difficult. "It was really saturated, and we couldn't pump over the tracks. So, we dug coffer dams and just kept pumping," Cook explains. "We also had to dig a small hole right in the middle of the culvert, barely a foot deep, basically to collect water and so

we had a place to put a hose end in. We filled it with concrete just before spincasting." Mucky conditions also meant that the staging area needed extra attention; pallets were put down for secure footing and anchors were used as needed on the withdrawal winch.

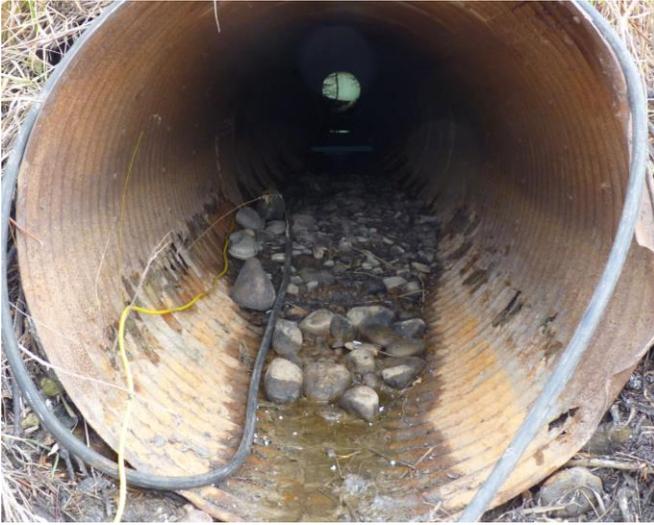
projects it had its unique challenges. It was a larger diameter pipe, 42", and it was longer, 85 feet, but both dimensions are well within CentriPipe capacity—runs of a few hundred feet are possible with CentriPipe. More significantly, this culvert was considerably more deteriorated than the Fairmount Road project, and several miles from the nearest railroad crossing, making logistics more difficult.

Debris in pipe before cleaning

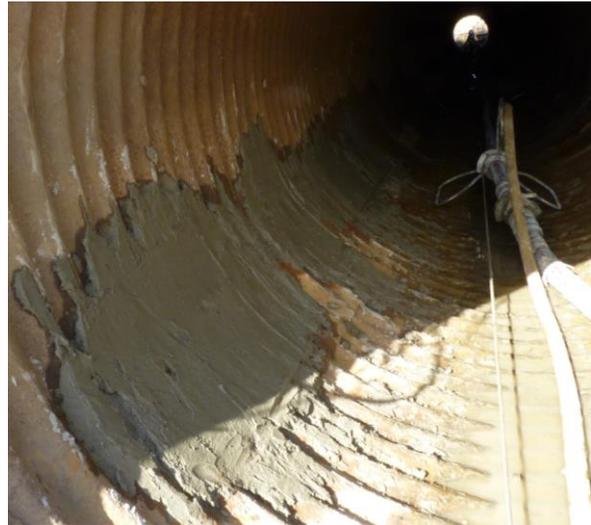
Patching and leveling of the invert using PL-12,000, and self-leveling material with 12,000 psi

To repair the rotted out invert, MuddRuckers poured two layers of PL-12,000, a self-leveling cementitious product

from AP/M Permaform. This created the smooth, level surface needed for steady spincaster withdrawal. PL-12,000 was also used for patching and repair of peeling sections of CMP.

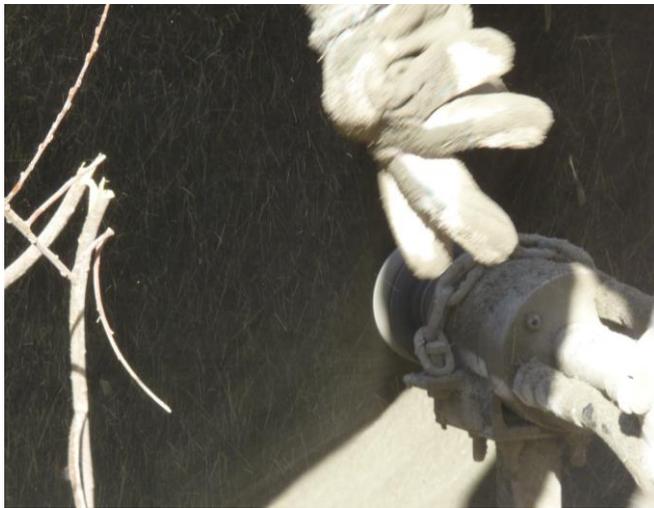
Centrifugally casting fine-aggregate composite concrete material, PL-8000, with CentriPipe spincaster

As in the Fairmount Road project, actual application was routine once the culvert preparation was completed. Again, two passes on consecutive days were used to apply a total thickness of one inch.

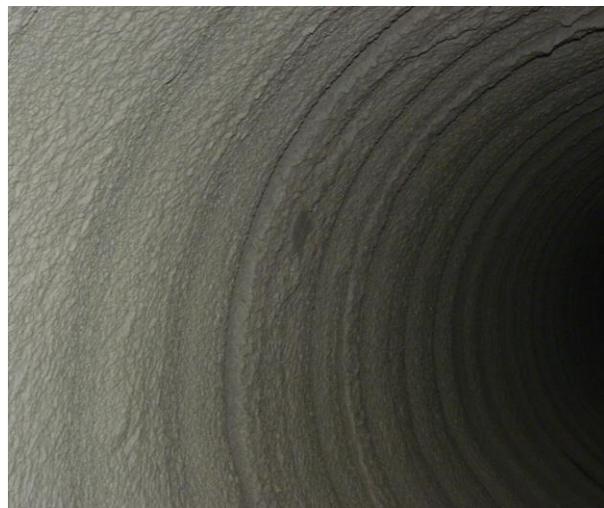
Interior walls of rehabilitated culvert are smooth, structurally sound, and water-tight
