To Do It Right, Do It Yourself: Genesee County Road Commission Invests in Catch Basin Repair Technology

by Angus W. Stocking, L.S.

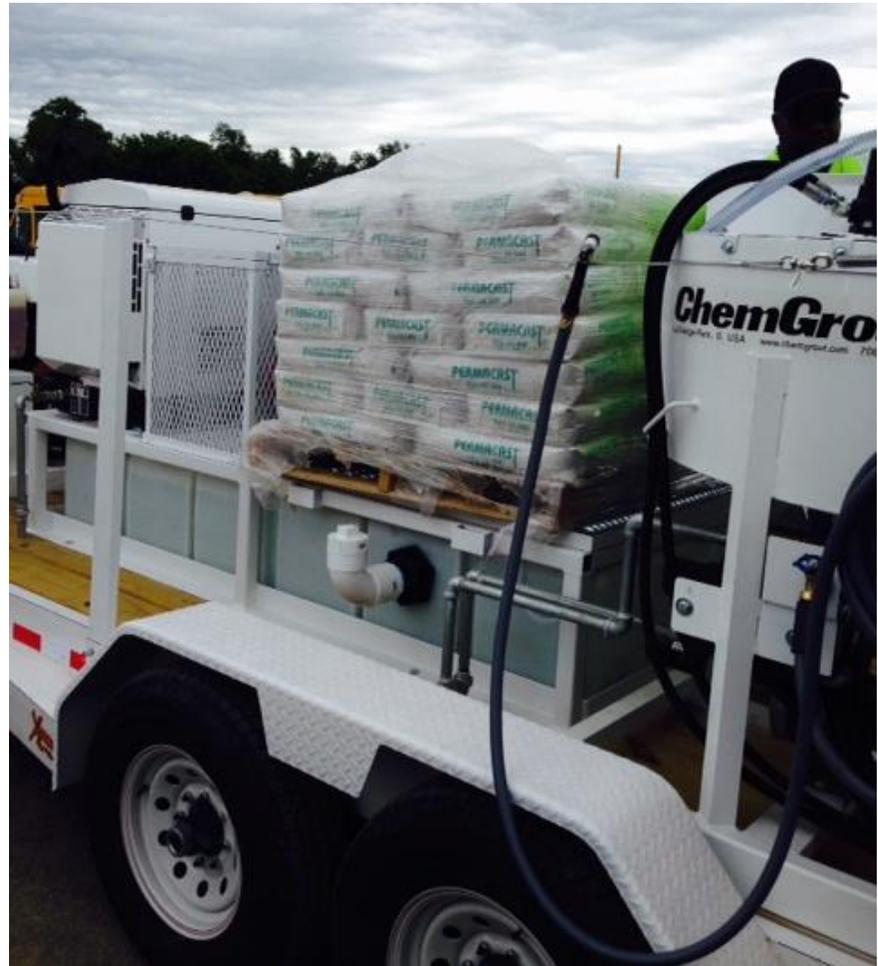
Genesee County repairs catch basins with county crews using the PERMACAST® PC-20HD (Hydraulic) Material Application Platform trailer and Permacast MS-10,000

The PERMACAST® PC-20HD (Hydraulic) Material Application Platform is a dual axle trailer, about seven feet wide and 20 feet

long, that supports a mortar mixer, a hydraulically powered progressive cavity pump, a bi-directional spincaster and spin

washer, and all the accompanying equipment—such as quick connect hoses, concrete spray gun, and 250-gallon water tank—needed to keep a crew working all day.

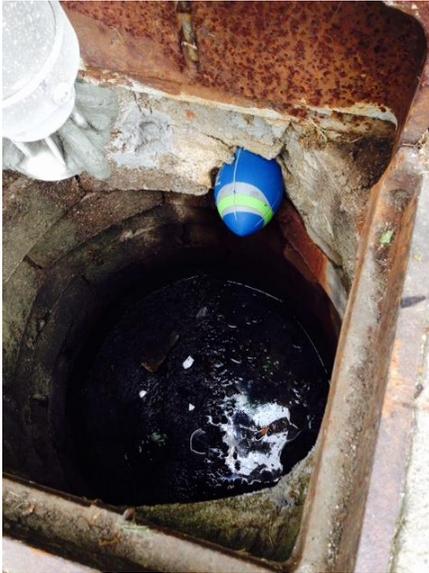
Preparing catch basin for rehabilitation

Nims says that the PERMACAST process is much more efficient. “Now we’re catching the basins before total failure. We inspect and clean them as needed, with the spinwasher on the trailer, then do minor repairs like filling voids and replacing loose block. If there are any inlet or outlet tubes we cover them with disposable bowl covers before spraying,” he says. “When all that’s done, we hook up the machines and mix the cement. Most basins take about five bags of MS-10,000, and that usually takes about five passes with the spincaster to get even coverage between an inch and an inch and a half thickness. Then we remove the bowl covers, replace grates, and we’re done.” Quality control is straightforward; by counting the bags of mortar used, Nims has a good idea of the total volume of material used, and a simple gauge can be used before the material cures to spot check layer thickness as needed.

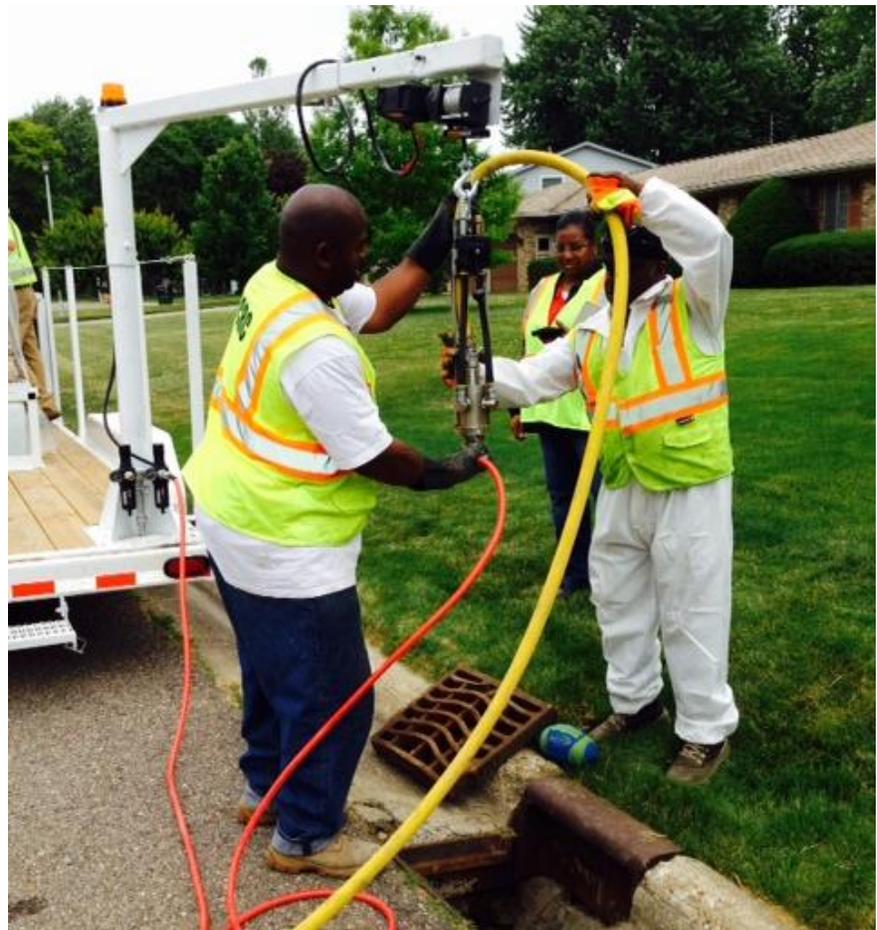
Lowering the bi-directional spincaster into the catch basin

The heart of the PERMACAST® system is the bi-directional spincaster, a technology pioneered by AP/M Permaform and used in several applications, including manhole rehabilitation and trenchless centrifugally cast

concrete pipe (CCCP) storm sewer rehabilitation. The spincaster sprays on thin, smooth layers of high strength cementitious mortars. In Genesee County, GCRC uses a winch to lower the spincaster into 36" x 48" (typical, some are deeper) brick catch basins, using multiple passes to spray on concrete layers about an inch and a half thick. For this application, AP/M Permaform's MS-10,000 is used, a fine aggregate, waterproof, corrosion resistant cementitious liner that adheres tightly to the brick substrate, forming a monolithic new 'pipe' that is sealed and structurally sound, independent of the original catch basin. "The seamless and structural aspects of the rehabilitation are excellent for our brick catch basins," says Dellaposta. "Really, the end result is a much stronger and better catch basin than the brick basins were even when they were new."

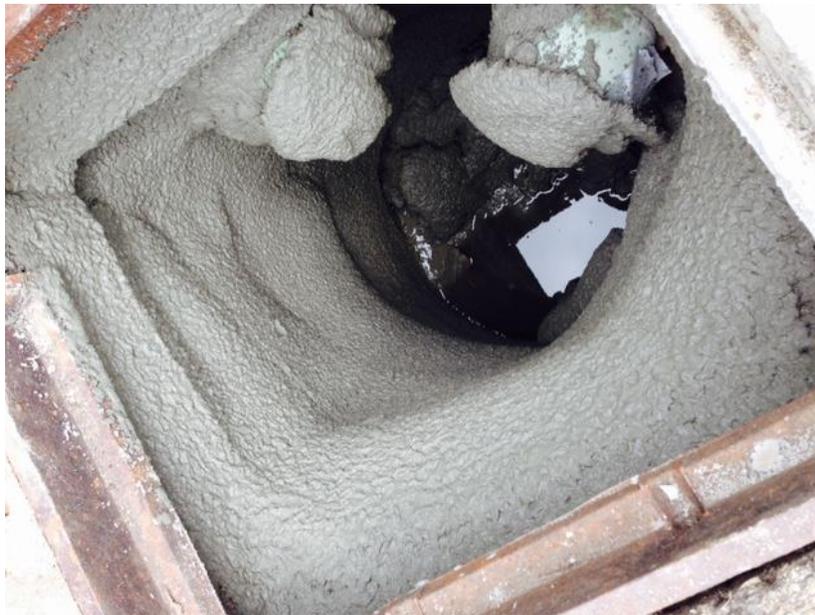
Fully relined and rehabilitated catch basin
