“THE RIGHT SOLUTION” SAVES PIPE AND ROADWAY

By: Angus W. Stocking, L.S.

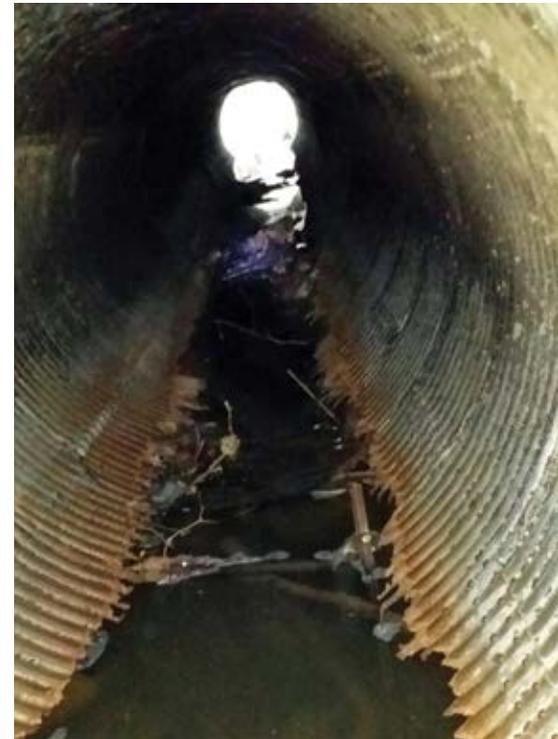
The CMP failed so completely along the invert erosion created a 3 ft. deep trench along the sewer bottom

A smooth bottom is needed for CentriPipe spincaster withdrawal, so most projects require some sort of resurfacing. In this case, Kincaid worked with a local batch plant to make a pumper truck available on short notice, and on Tuesday the Ace crew was able to fill in the eroded trench with ten cubic yards of diggable fill, which they then topped with a few inches of sprayed and troweled PL-8000, a high-strength, workable engineered cementitious product from AP/M Permaform. After a solid day's work, they had the smooth strong surface they needed to begin spincasting the next day; in the area of the eight-inch gap, they filled in and beveled to make an even transition. Dewatering was accomplished with coffer dams and a two-inch pump, and to complete

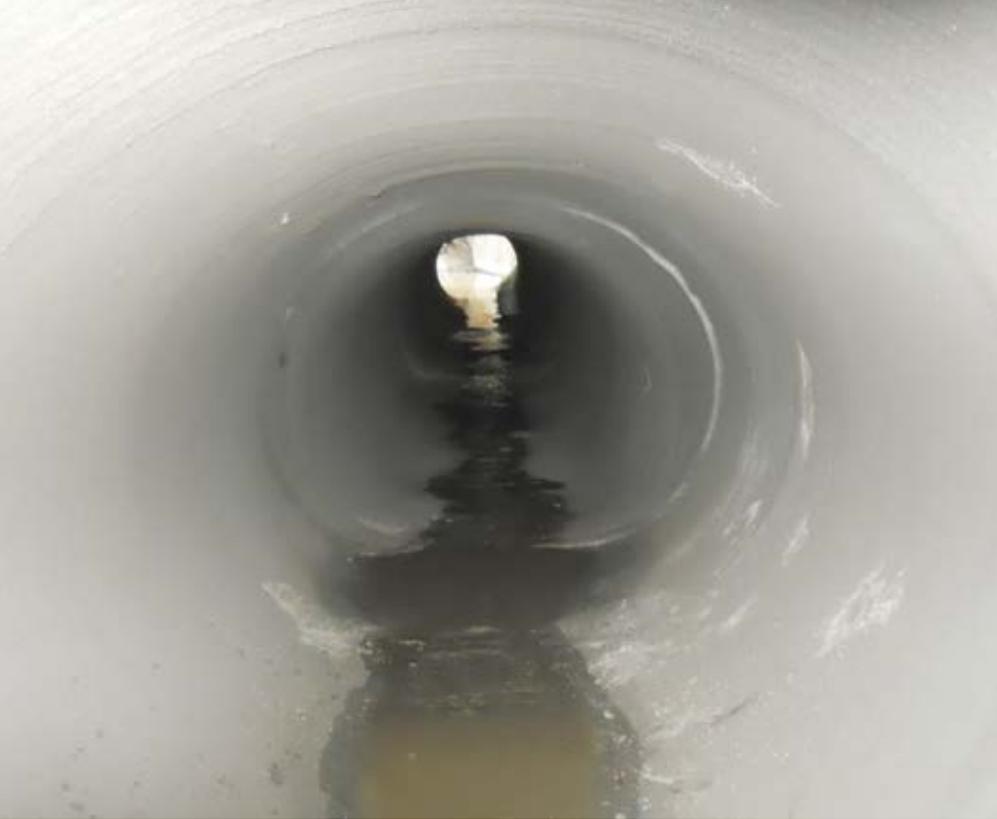
Sewer rehabilitation was completed on schedule, even with the surprise 'canyon' to fill

Work began on Wednesday morning with the placement of ‘depth pins’; since the cement layers applied are thin, it's important that each layer be applied evenly. Ace uses a standard rivet gun to set aluminum rivets at 12:00, 3:00, 9:00, and (sometimes) 6:00 (viewing the pipe diameter as a clock face), every 20 feet or so along the sewer, then trims the rivets to an inch. This gives CentriPipe sled operators a good visual gauge of thickness as layers are applied and, at project end, assures that the final design thickness—one and a half inches in this case—has been reached. For a redundant check on final thickness, Ace

also tracks material volume used; in Jerseyville, about 4.5 pallets were used, translating to an applied volume that exceeded design specifications.
